Yorkshire Peat Partnership

WORKS MONITORING REPORT

May 2017

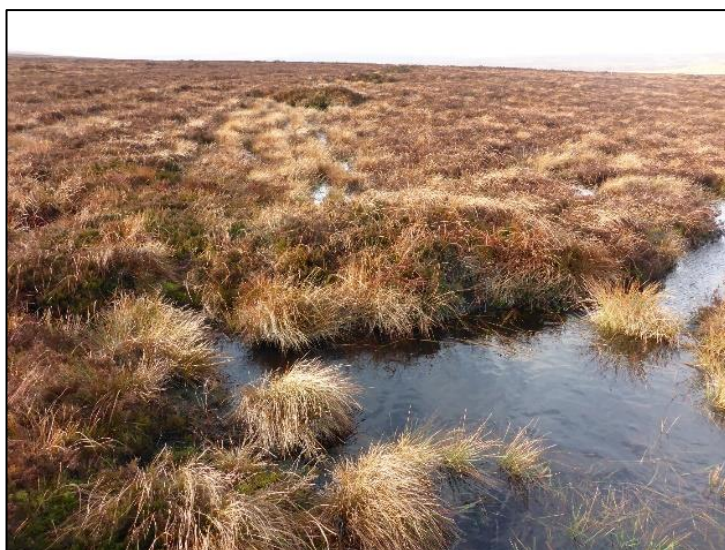
Figure 2: Peat dam on Hardcastle Moor, 2017

Overall the results were very encouraging with an average of 94% of all the 763 dams assessed being intact; only 12% showing signs of erosion; and an average of 72% of the surface area having successfully revegetated (Table 2).

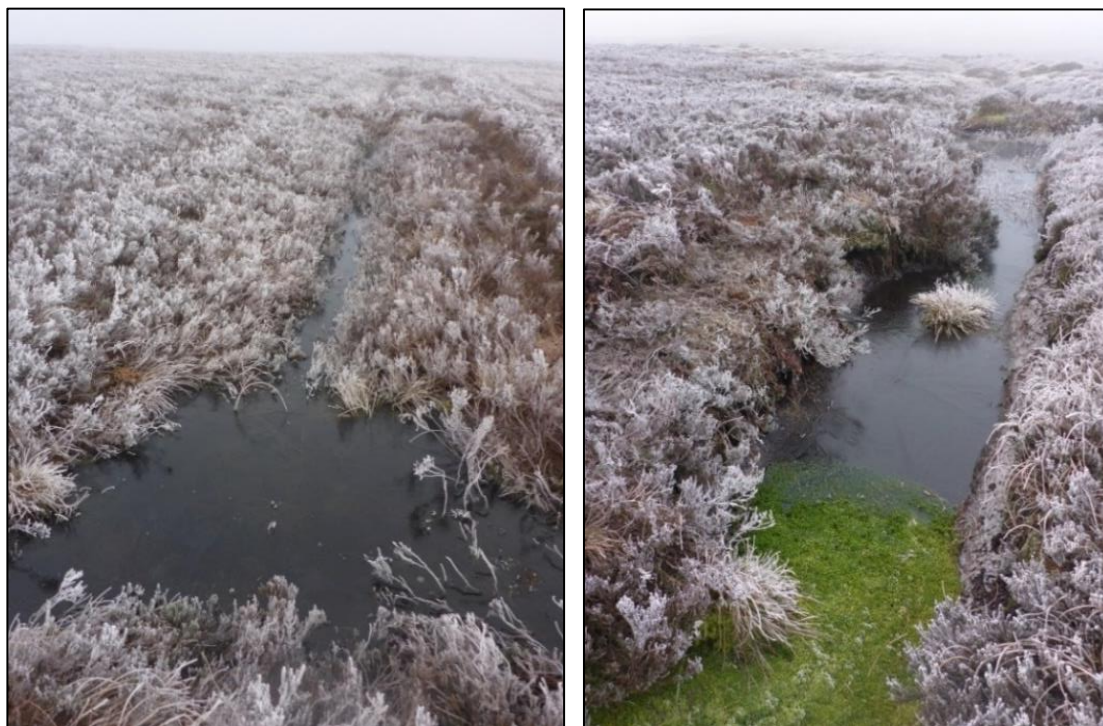
Figure 3: Gouthwaite Moor, 2015: a reprofiled grip (left) and a non-reprofiled grip (right).

The practice of reprofiling was common in the early years of YPP's restoration work but was recently discontinued following evidence that it may increase the release of methane (Green, S., Boardman, C., Baird, A., 2011). However, through the monitoring process a number of interesting differences between reprofiled and non-reprofiled grips began to emerge which may benefit from a more detailed investigation. Visually, the reprofiled grips appear to have revegetated faster and are potentially less vulnerable to erosion than their non-reprofiled counterparts (Figure 3 & 4).

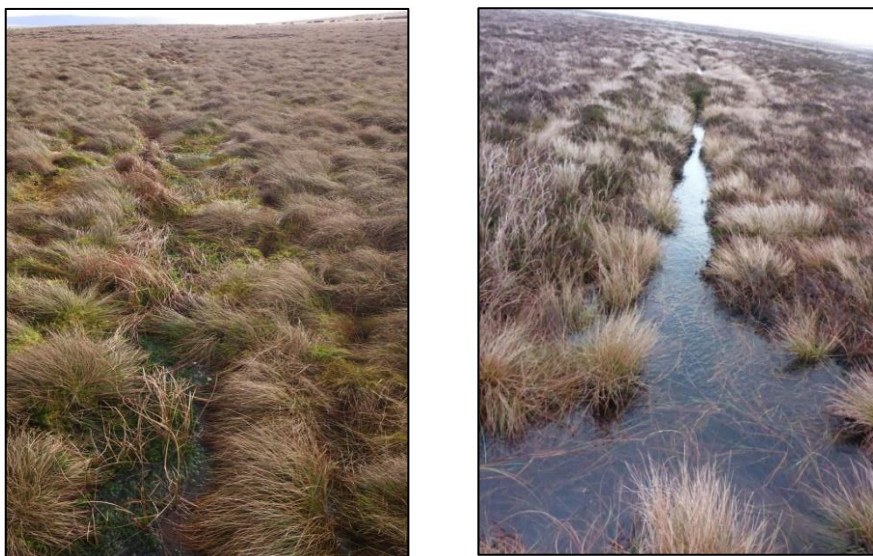
What is very apparent is that reprofiled grips had a much higher percentage of vegetation cover (82%), compared with that of non-reprofiled grips which had an average of 65%. This was even the case for grips completed at the same time (Figure 4).

Figure 4: A reprofiled grip on Kelber moor (left) and a non-reprofiled grip on Hardcastle moor (right), both completed in March 2014.

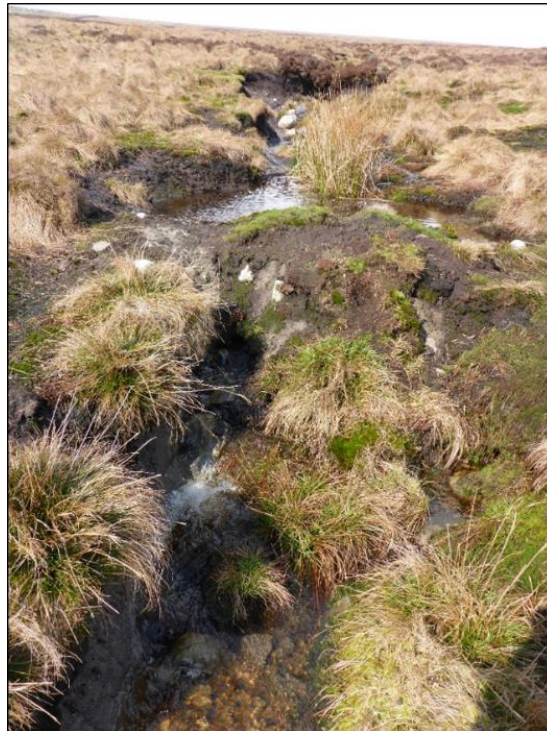
Erosion of peat dams and restored grips was found to be a particular problem on sites with steeper gradients and higher run-off such as The Preserves (Figure 5 & 6).

Figure 5: Erosion of previously restored grip and peat dam, The Preserves, 2017

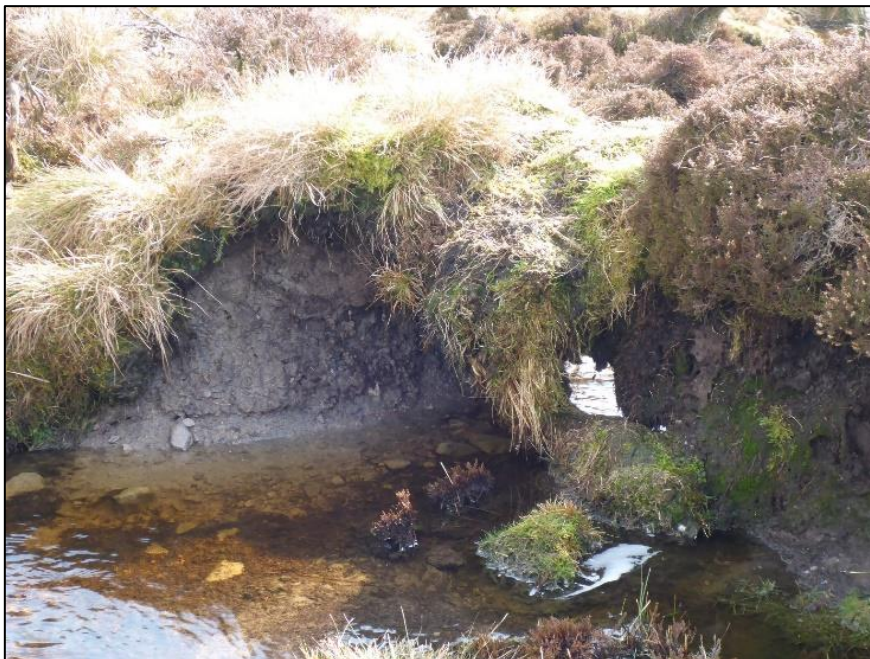
Here only 77% of peat dams were intact compared with an overall average across the sites of 95%. At the time of the site visit water run-off was high and flowed unimpeded across the steeper parts of the moor, subjecting dams lower down to a great deal of force. Clearly, over time this has led to problems including dams being undermined by flowing water (Figure 6).

Figure 6: Eroded peat dam on The Preserves, 2017

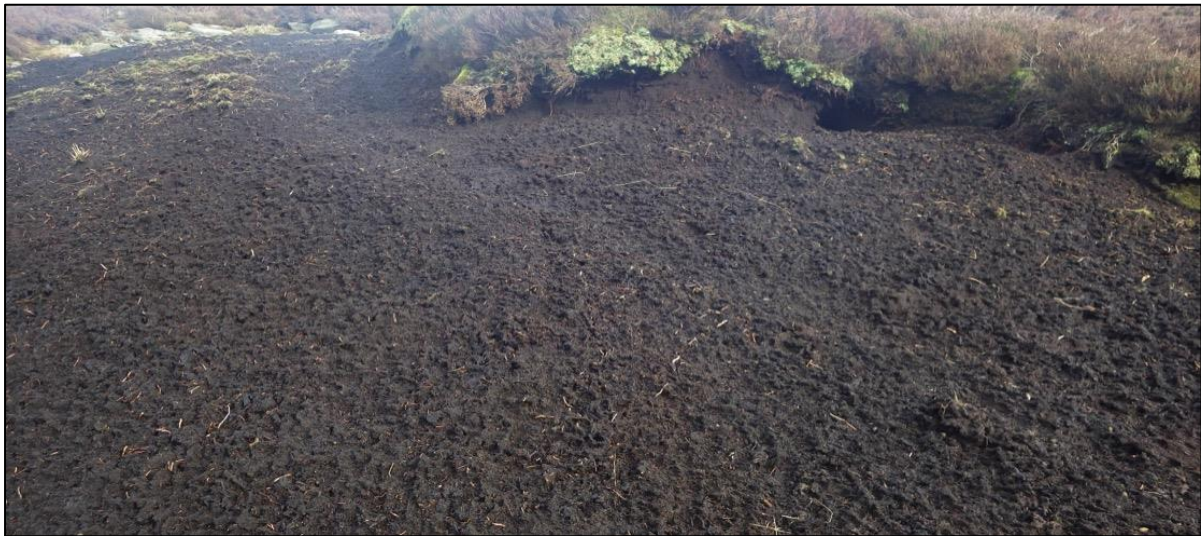
Results from monitoring the success of revegetating areas on bare peat were very mixed. Within one site the range of revegetation cover varied from 0-100% (Figures 12a. & 12b).

Figure 12a. Bare peat on Grimwith Estate (2017) showing an area with no revegetation

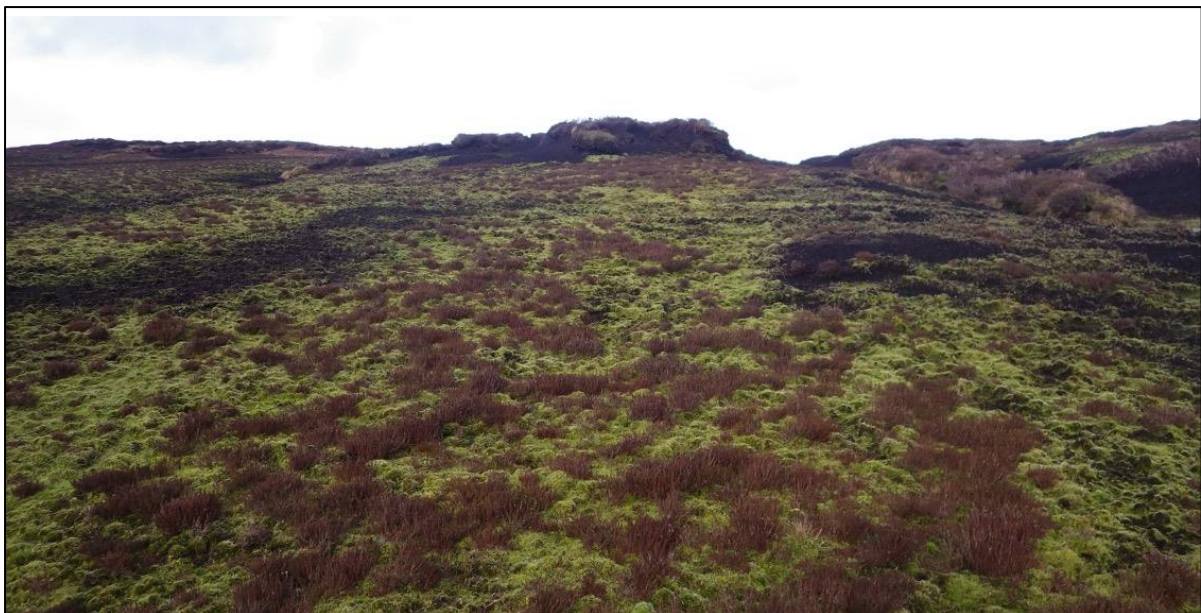
Figure 12b. Bare peat on Grimwith Estate (2017) showing an area with 100% vegetation cover

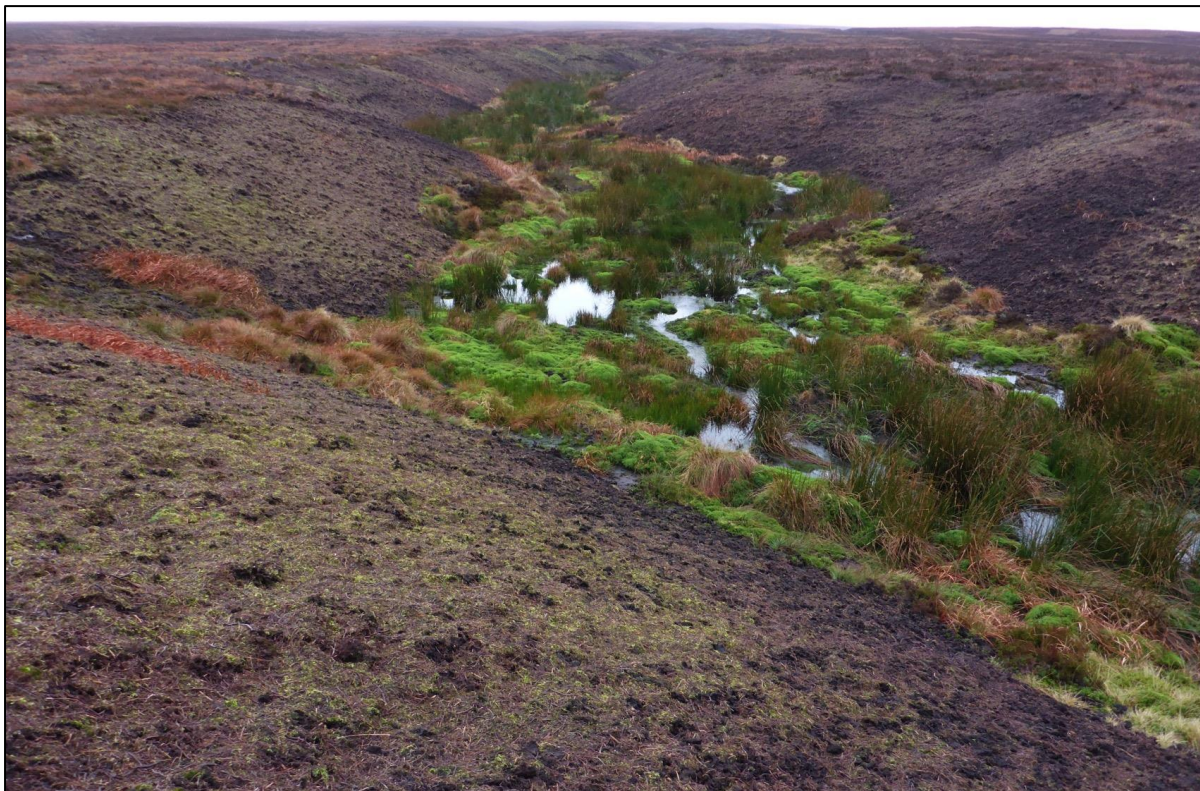
Many of the revegetated sites where low vegetation cover was recorded were restored using techniques that have since been modified. Applications of brush, dwarf seed and 'nurse' grasses have been increased and less suitable lowland grass species have been replaced by upland varieties better adapted to local conditions. Cotton grass plugs were also introduced last winter, targeting wetter areas. Although it is not possible to predict the success of the revegetation from recent work using these updated techniques, the first signs are promising (Figure 13).

Figure 13: Ramsgill (2017) reprofiled and revegetated gully sides, one year after works completion.

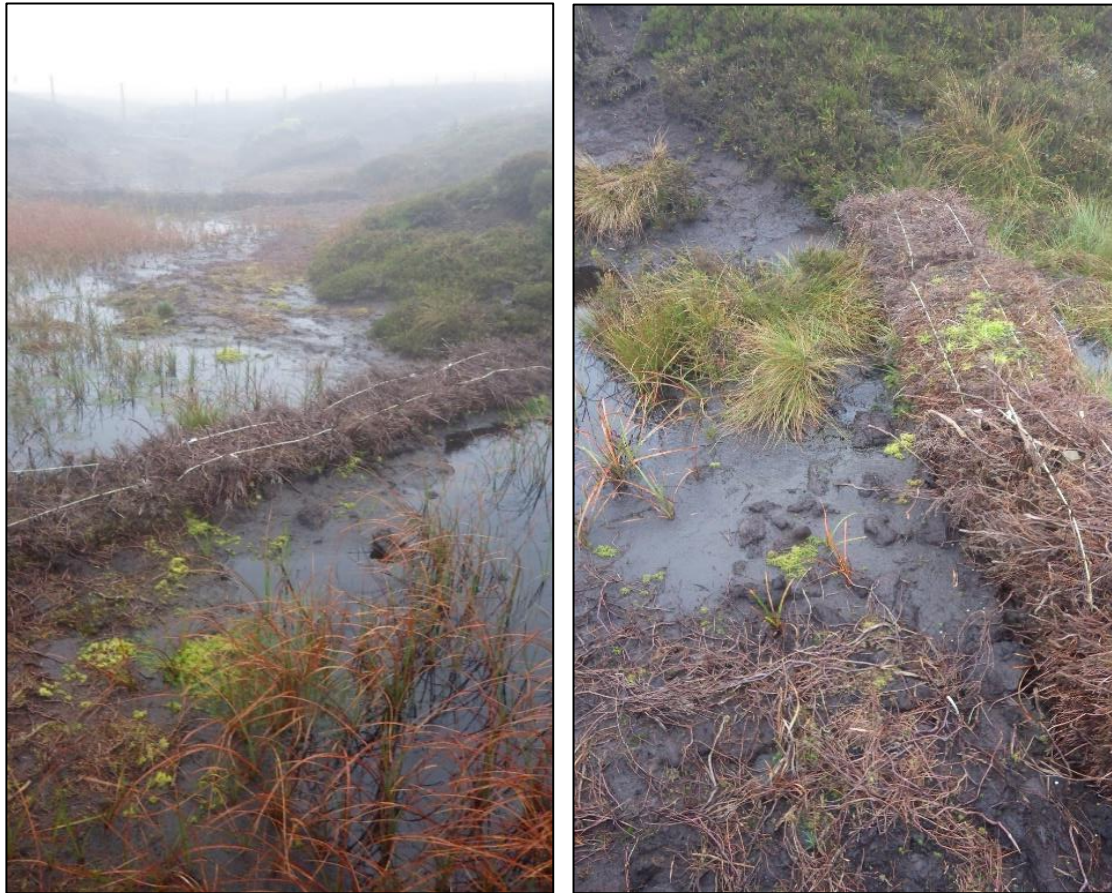
It is also encouraging that Cragdale, only a year after restoration works were completed, has one of the highest average percentages of revegetation (56%). This may be attributable to the use of heather

bales to slow run-off, trap sediment and provide shelter, reducing erosion and allowing new seed and cotton grass plugs to establish (Figure 14a & 14b).

Figure 14a & 14b. Cragdale (2017) showing the use of heather bales to help with revegetation
