Mires-on-the-Moors Hydrological monitoring summary

Exmoor Mires Project 2010-2015 Feb 2011

BEFORE AND AFTER EXAMPLE PICTURES OF MIRE RESTORATION SITES

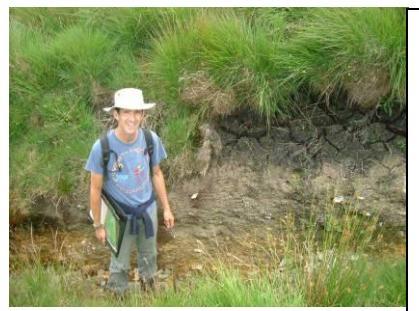
In the ditch before restoration

The ditch was fenced, over 3m deep, eroding and cracking, drying out the peat with large chunks dropping of the side in to the ditch. The restoration contractor put in 16 wooden blocks, backed up with peat sourced from borrow pits. The ditch was filled with locally cut moorland bales and these were covered over with ditch spoil from the bank on the side of the ditch.

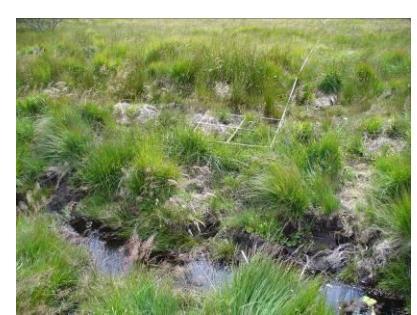
Ditch after restoration

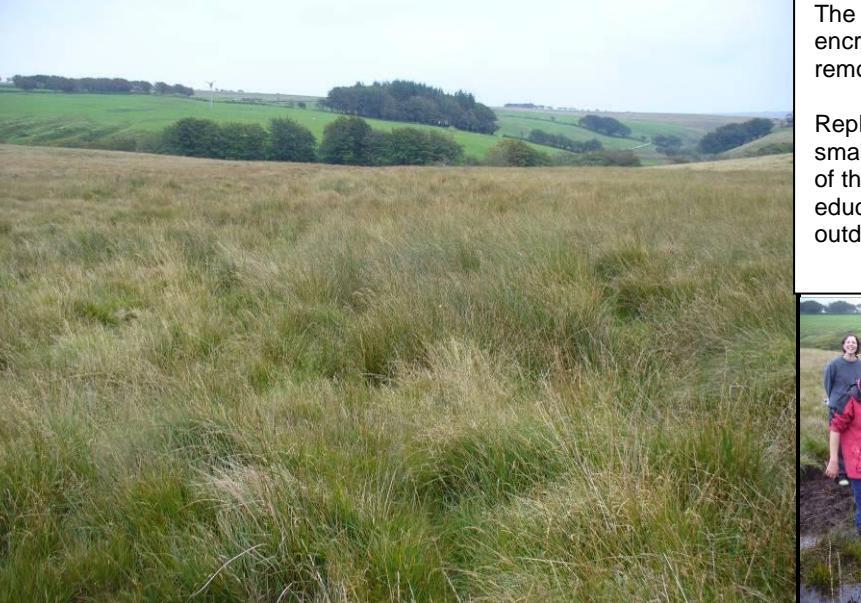
The ditch, fence and scrub encroachment are now gone (all removed by the contractor).

Replaced by some new pools in the small peat borrow pits along the line of the ditch (being enjoyed by an educational group from Pinkery outdoor centre)

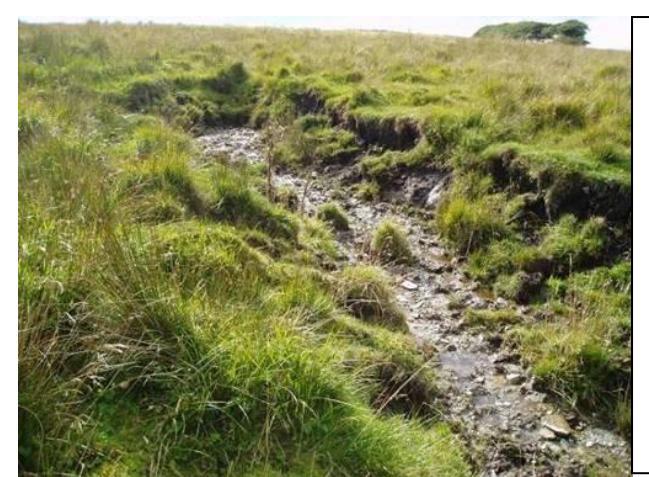
BEFORE

Ditch before blocking (left), the site was eroding back from the spring head with lots mobile peat and shillet in the gully bottom

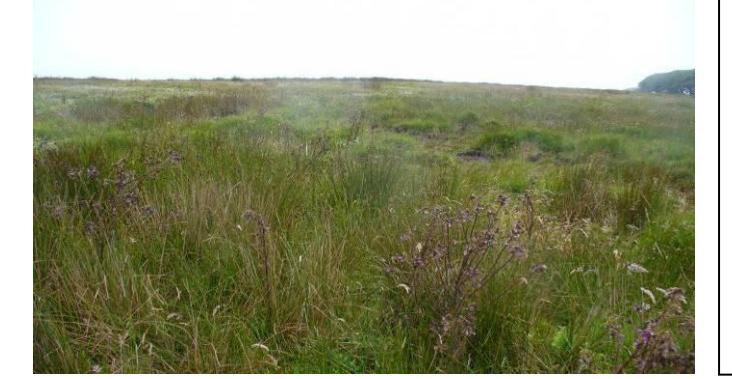
AFTER

View of filled in ditch in August 2010 (left). The small areas of bare peat visible are the partially vegetated peat borrow pits, from which peat vas derived to seal the wooden dams

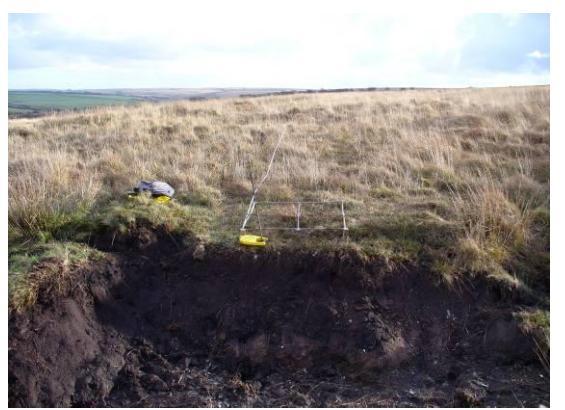
View of the vegetation monitoring transect in 2006 (bottom left) and 2010 (bottom right). Note and compare the position of the tape which was relocated to the exact spot marked by wooded pegs - **The ditch is completely gone!**

Before - bare eroding peat in ditch

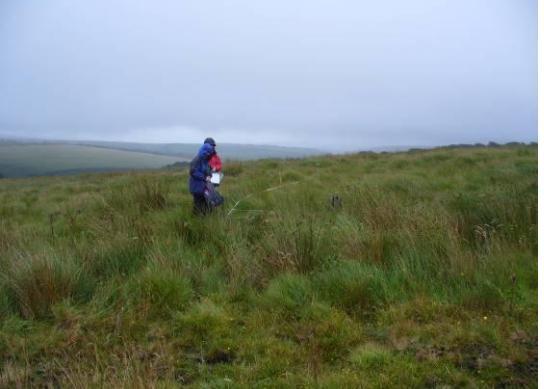
After- no evidence of ditch remains

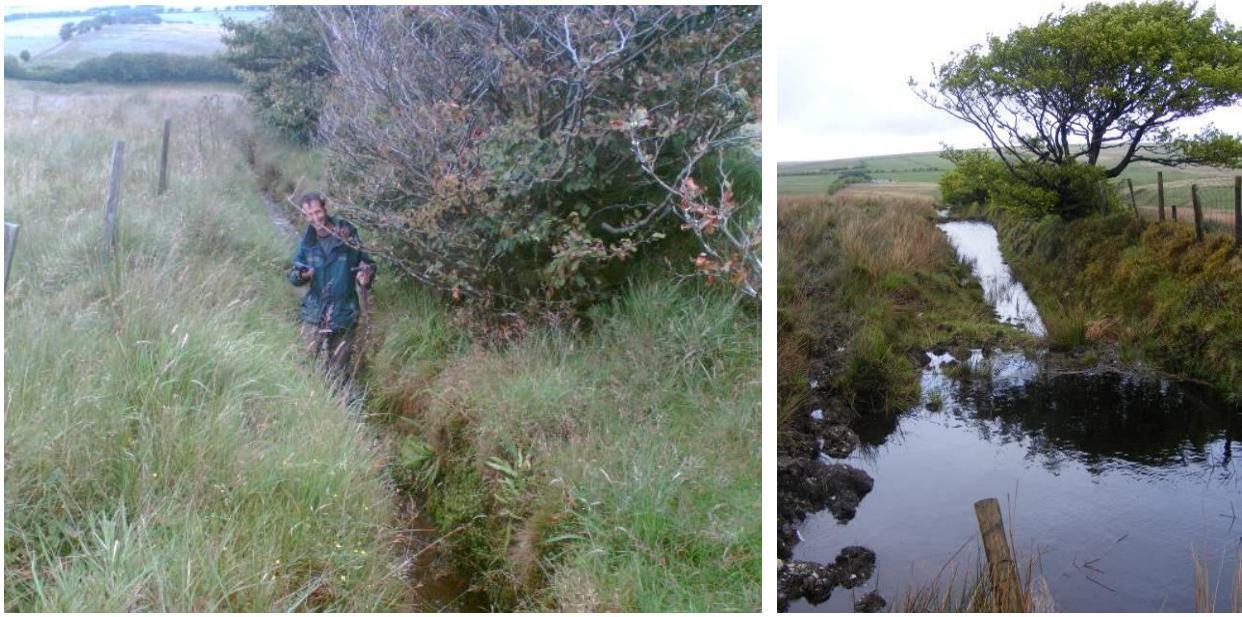
i.Boundary Ditch Aug 2008 ii. Boundary ditch immediately after restoration works

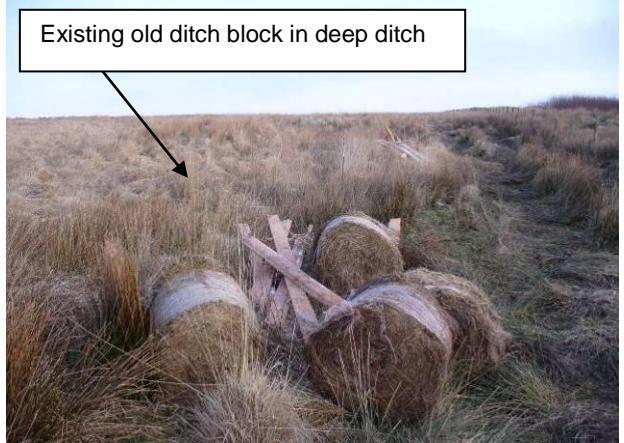
Before (construction materials at the ready)

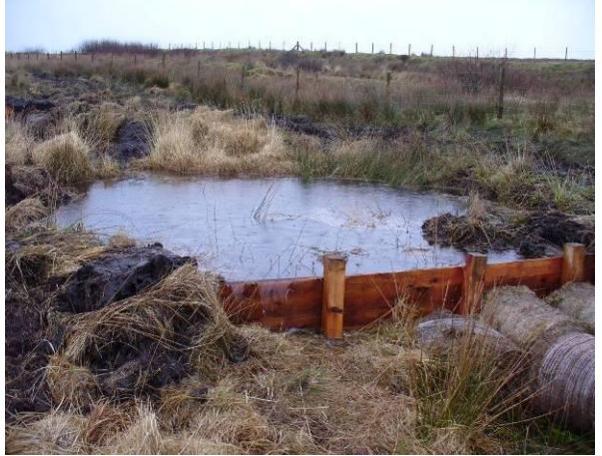
Immediately after construction of a new block

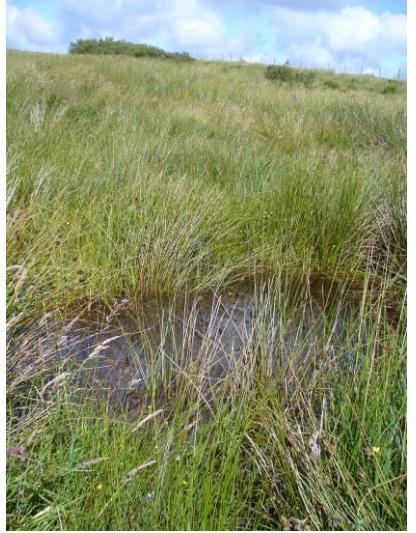
August 2010 -block hardly visible

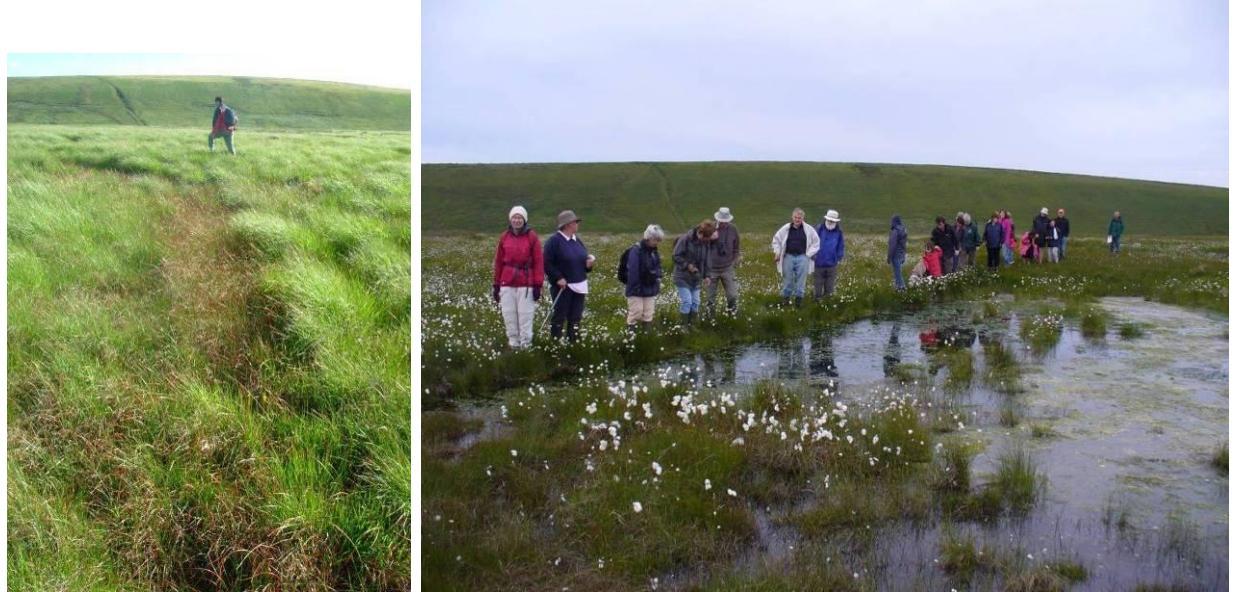
Dry peat cuttings in Summer 2006 and 1 year after blocking with peat (photo 2008)

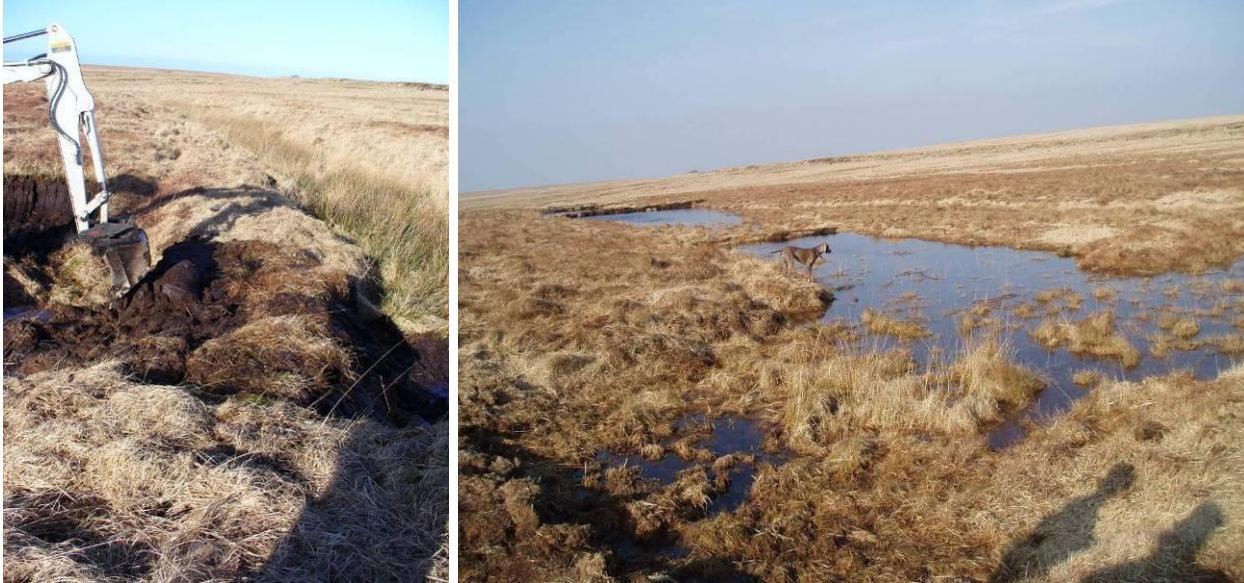
Just before the ditch was blocked in March 2006 and 1 year later

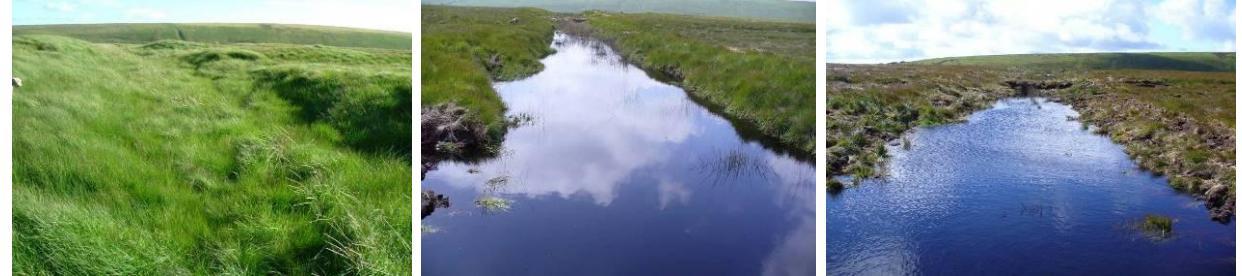
Main drain before blocking- summer 2006, After blocking (March 07) in summer 2007 and after bank re-profiling in August 2007

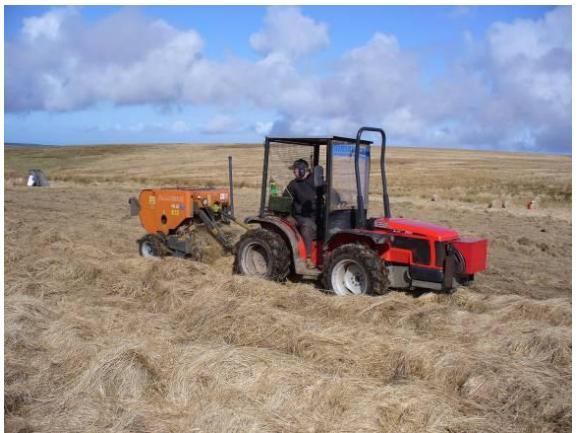
Cutting and baling moor grass

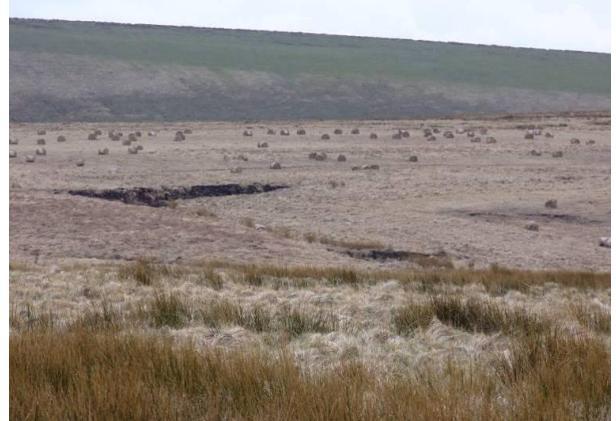
Moorland bales and peat dams

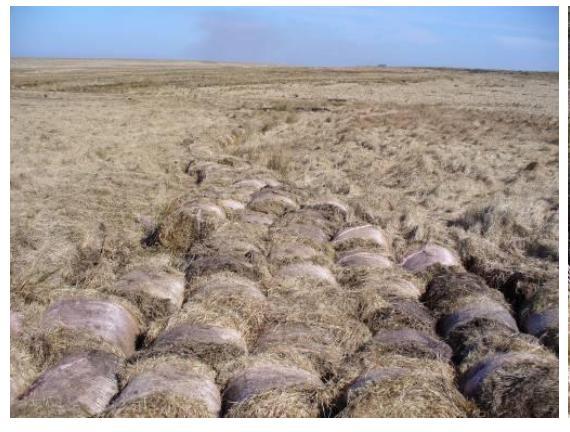
Using bales to block gullies

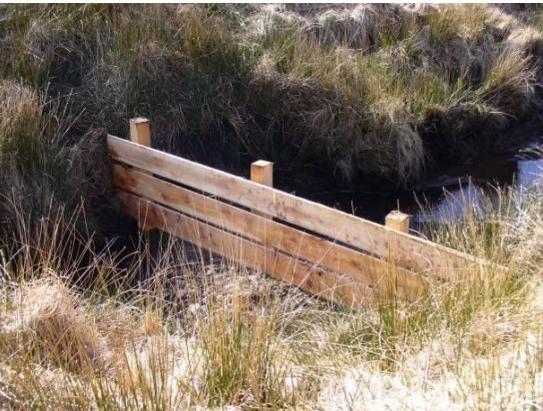
Fence across gully to hold bales

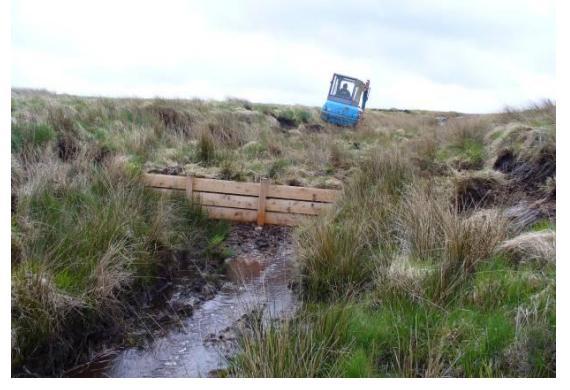
Bales being put in place

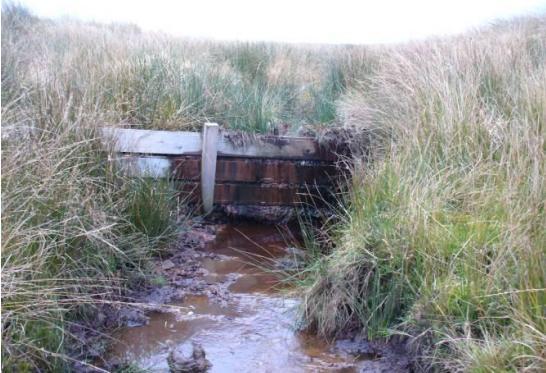
Bale block - 1 year later
