LIFE Active Blanket Bog in Wales

Summary of Research and Monitoring

Feb 2011

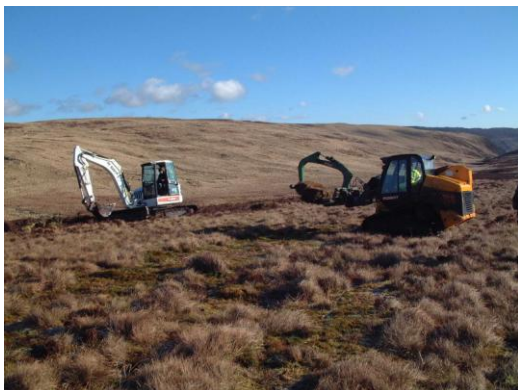
Drain blocking at Lake Vyrnwy using heather bale and peat dams

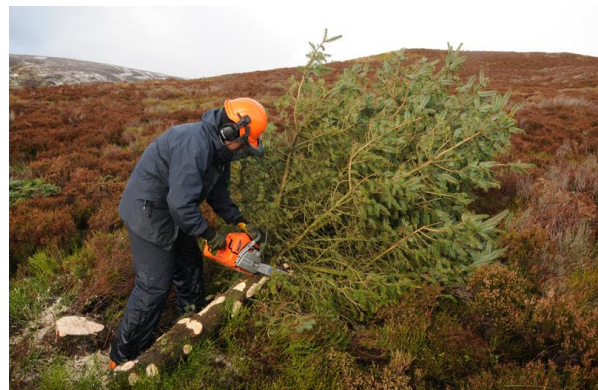
Removal of self-seeded Sitka spruce at Lake Vyrnwy
