Monitoring cutaway peatland rehabilitation in Ireland

Progress and challenges

Mark McCorry

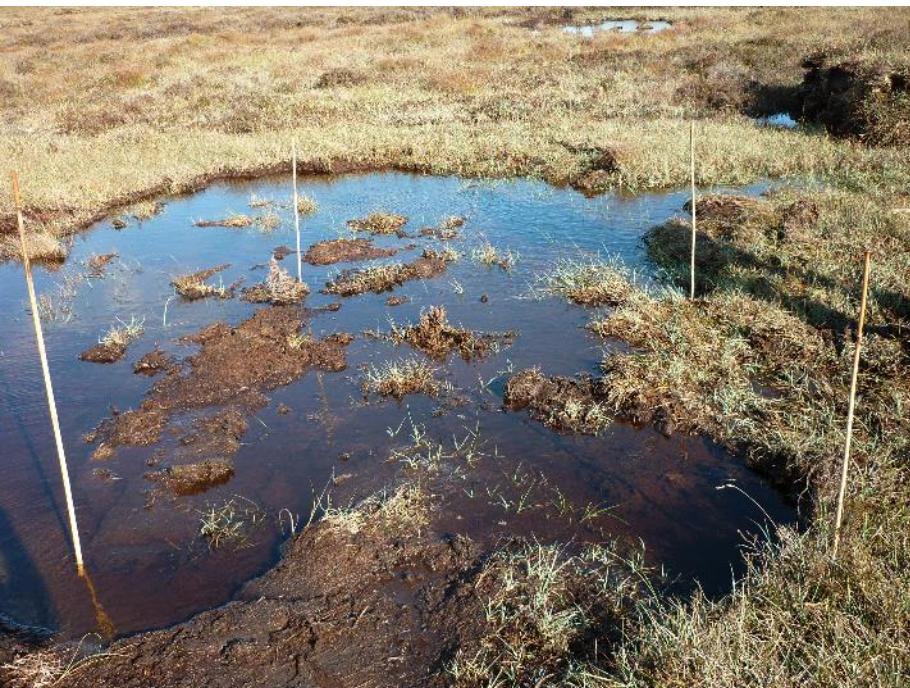
Table 3.1: Comparison of *Sphagnum* cover for Permanent Quadrats 1-5 (2012 & 2017).

Quadrat No.	2012	2017
1	10-20%	50-60%
2	5-10%	25-30%
3	20-30%	40%
4	20-30%	40%
5	1%	10%

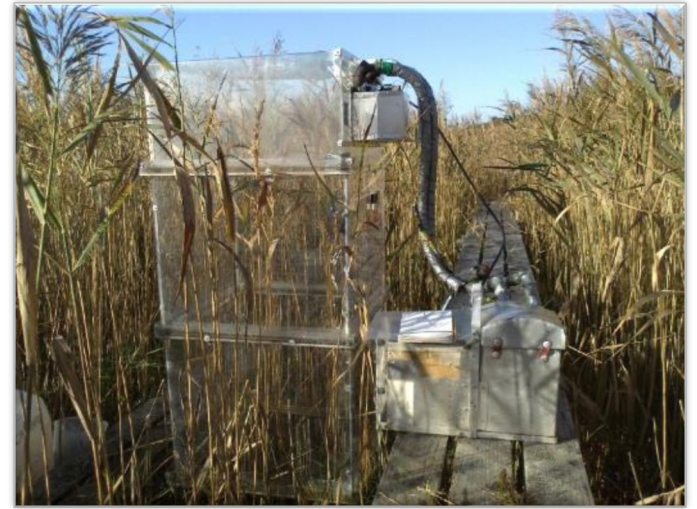
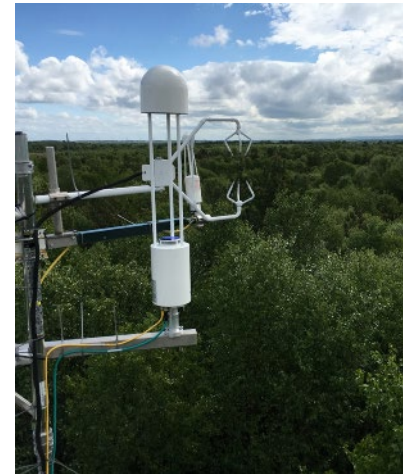
Lullymore
Carbon flux tower (UCC/TCD/WIT)
PhD 2019 supported by BnM

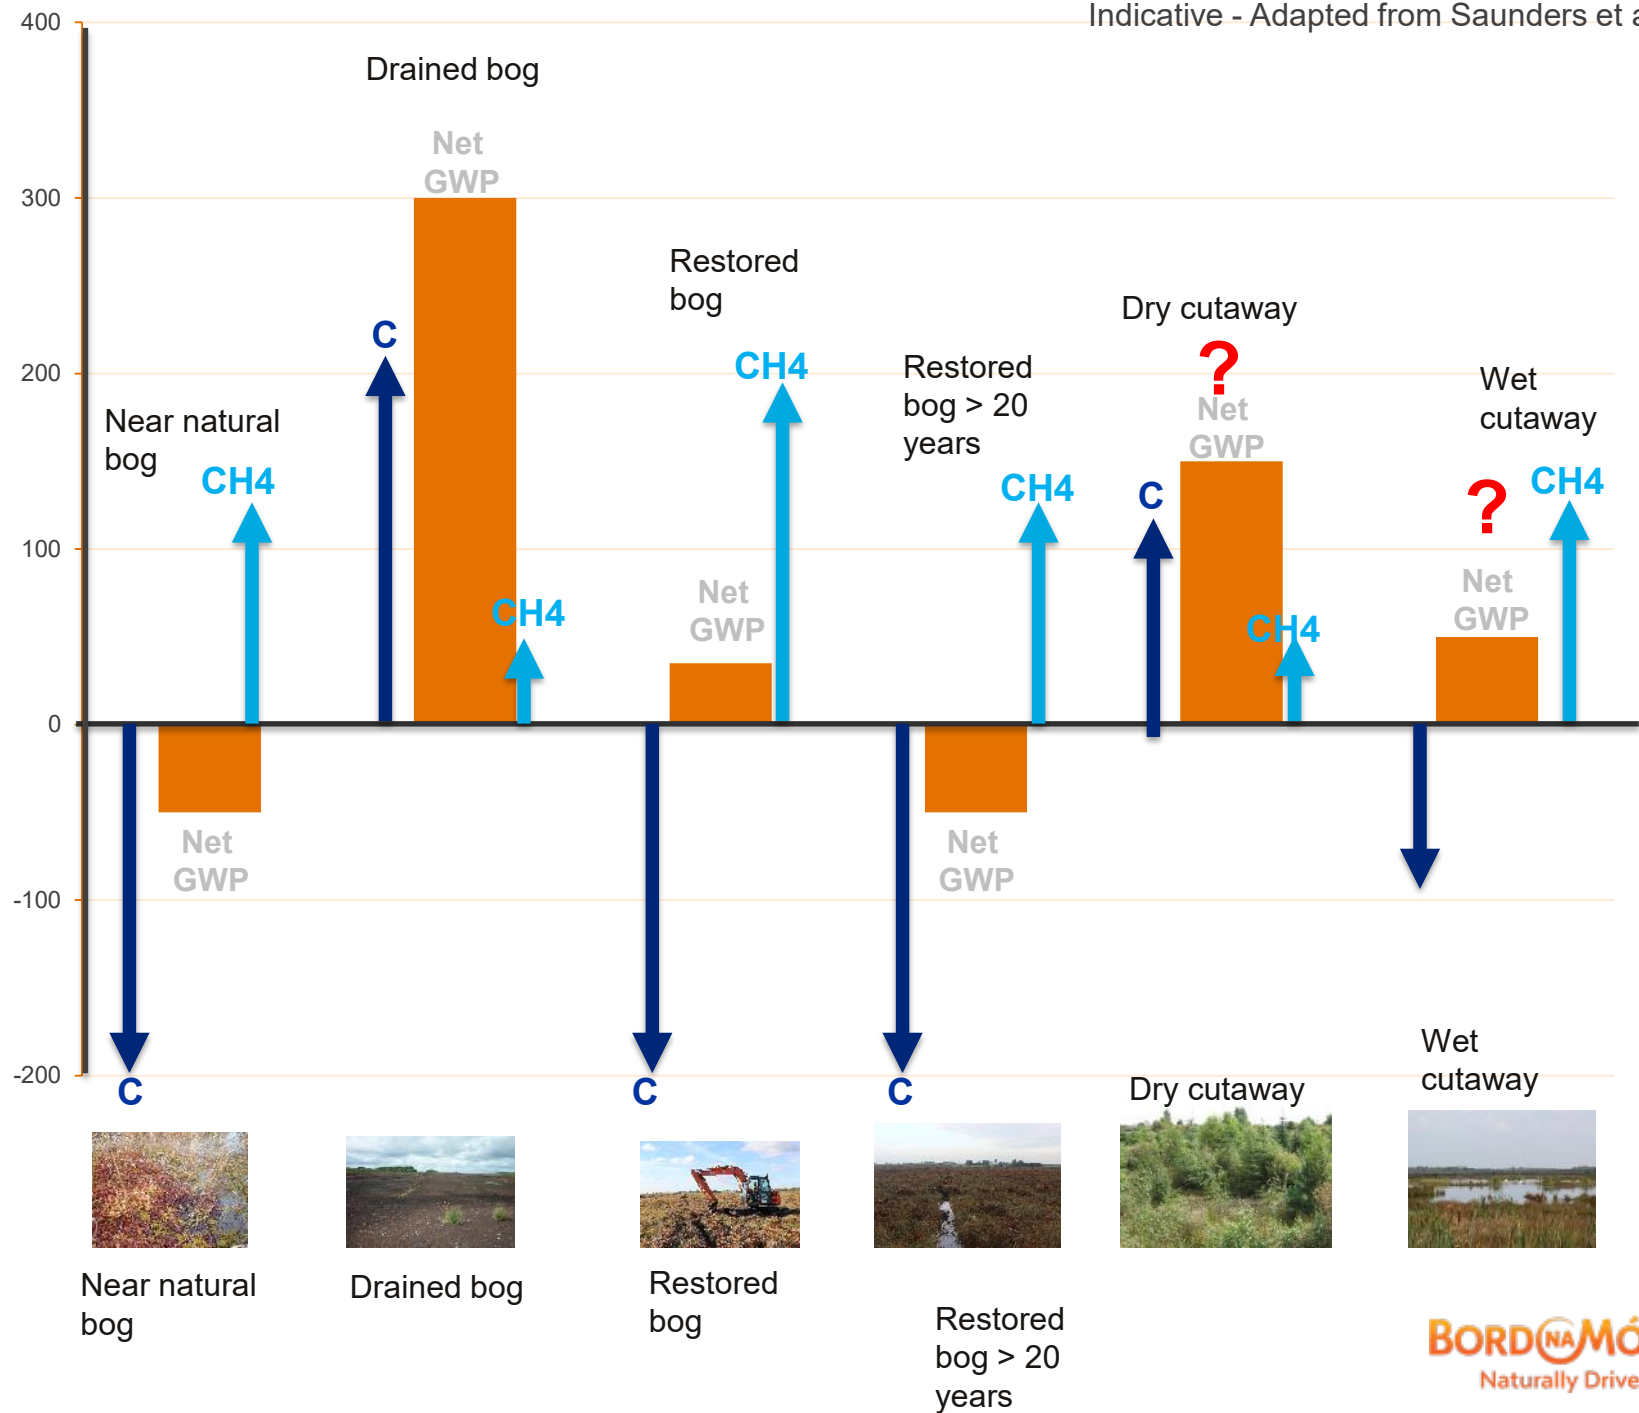
Tonnes CO₂e per km² per year
