# ***Exmoor : A Case Study, peatland restoration and the historic environment***

# Exmoor Mires Partnership

Main Objective: Eco-hydrological restoration of Exmoor's peatland for multiple ecosystem service benefits (catchy!)

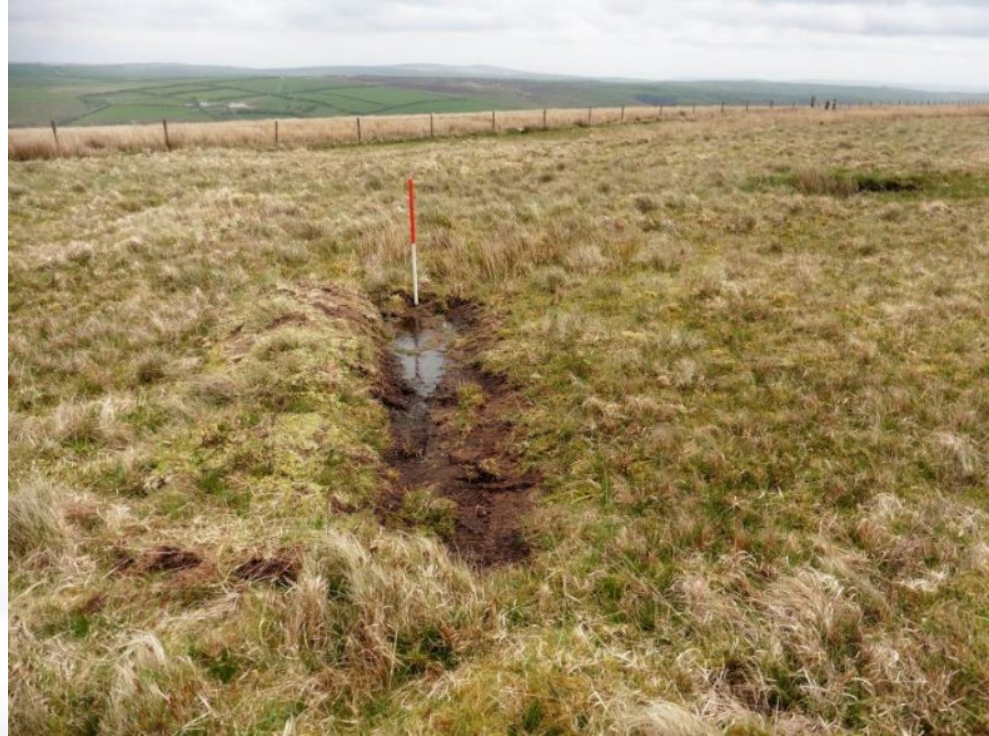
Single block in cutting exit

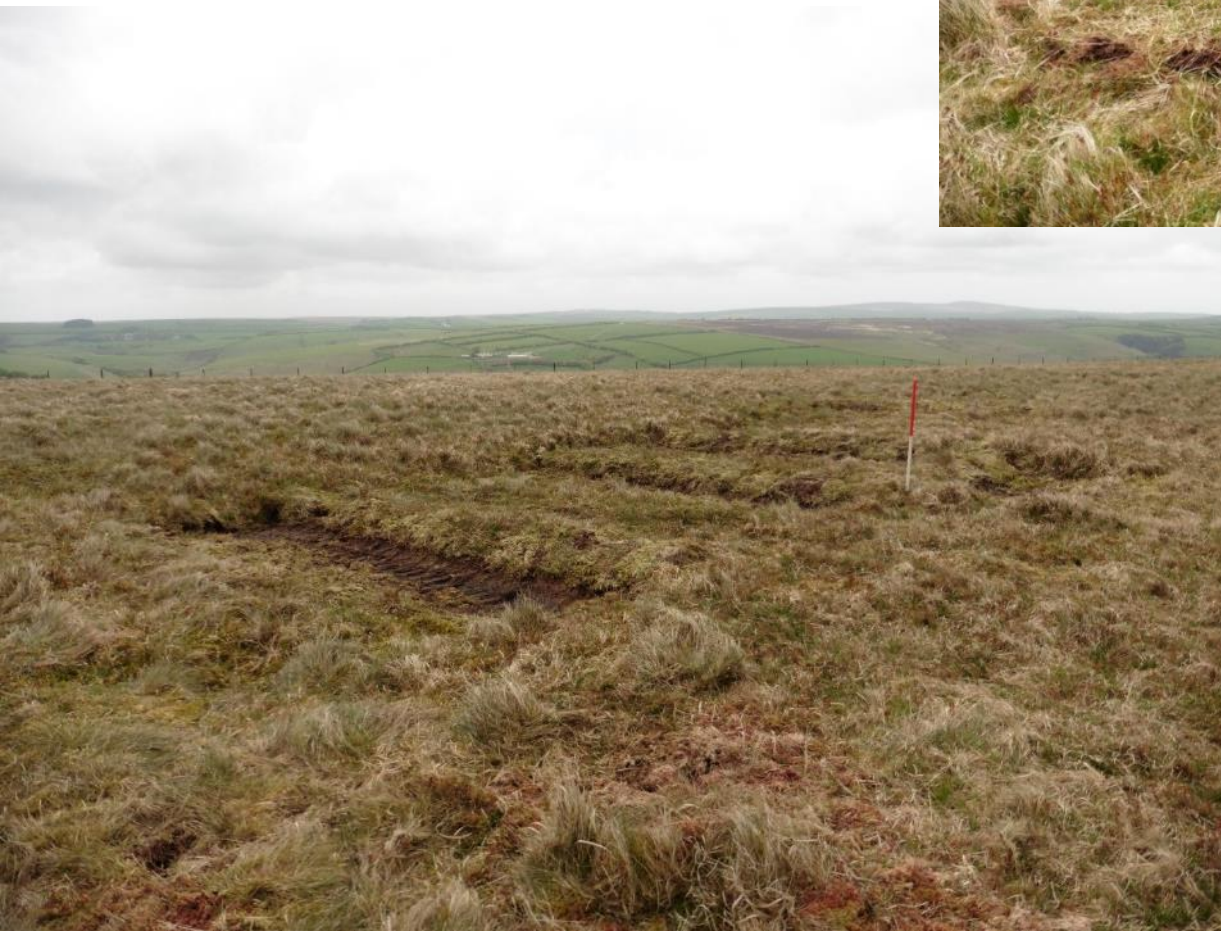
Multiple blocks to  
create cells
