Peatland Restoration and Natural Flood Management

Exmoor Mires Partnership: Morag Angus; Conrad Barrowclough, Dr Martin Gillard

Horsen Farm, September 2018

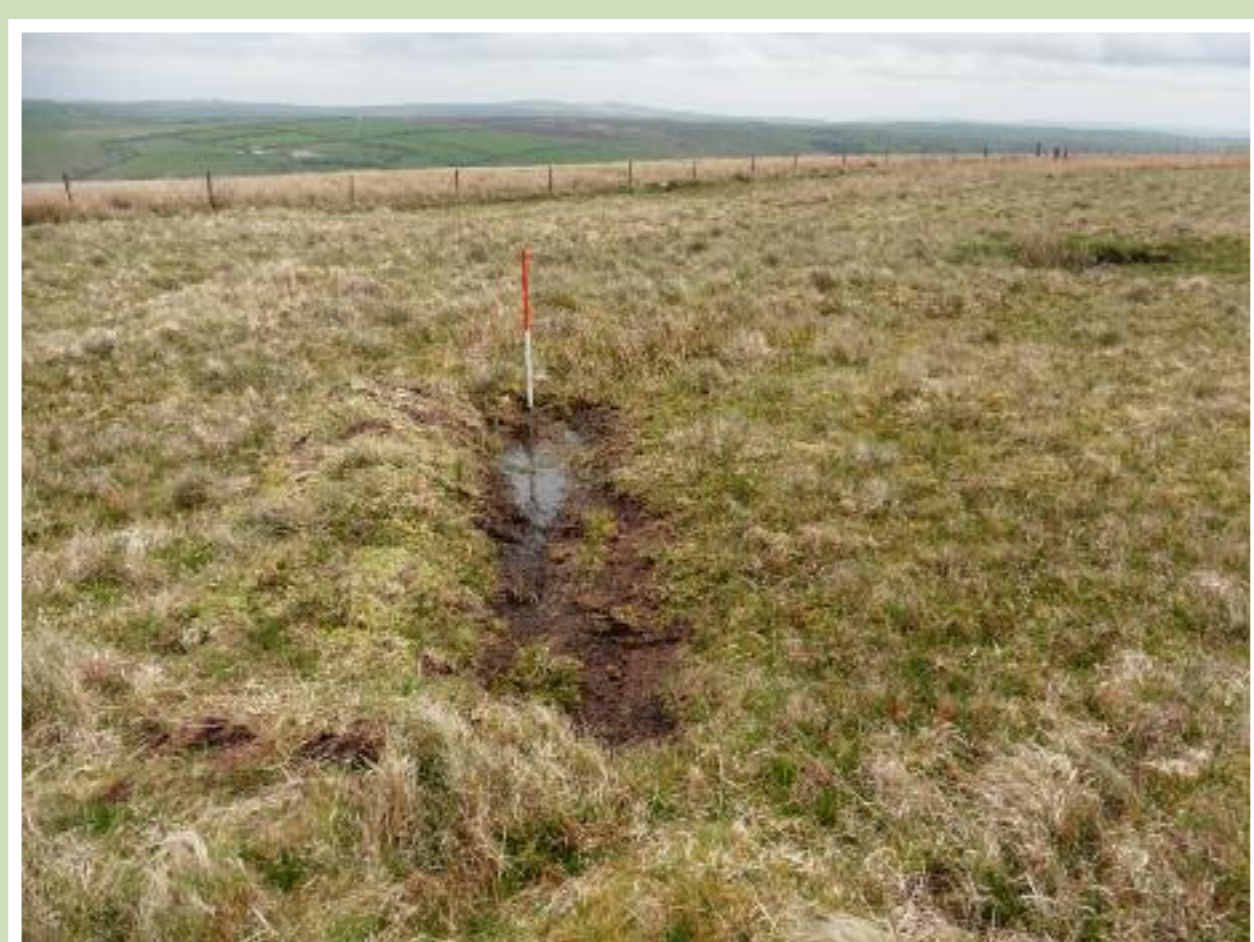
Left: Block made of peat to block exit point of a peat cutting.

We worked with the landowner to devise a programme of works that would start the process of addressing these issues. This involved using well known and established peatland restoration techniques to block peat cuttings and ditches at the top of the catchment.

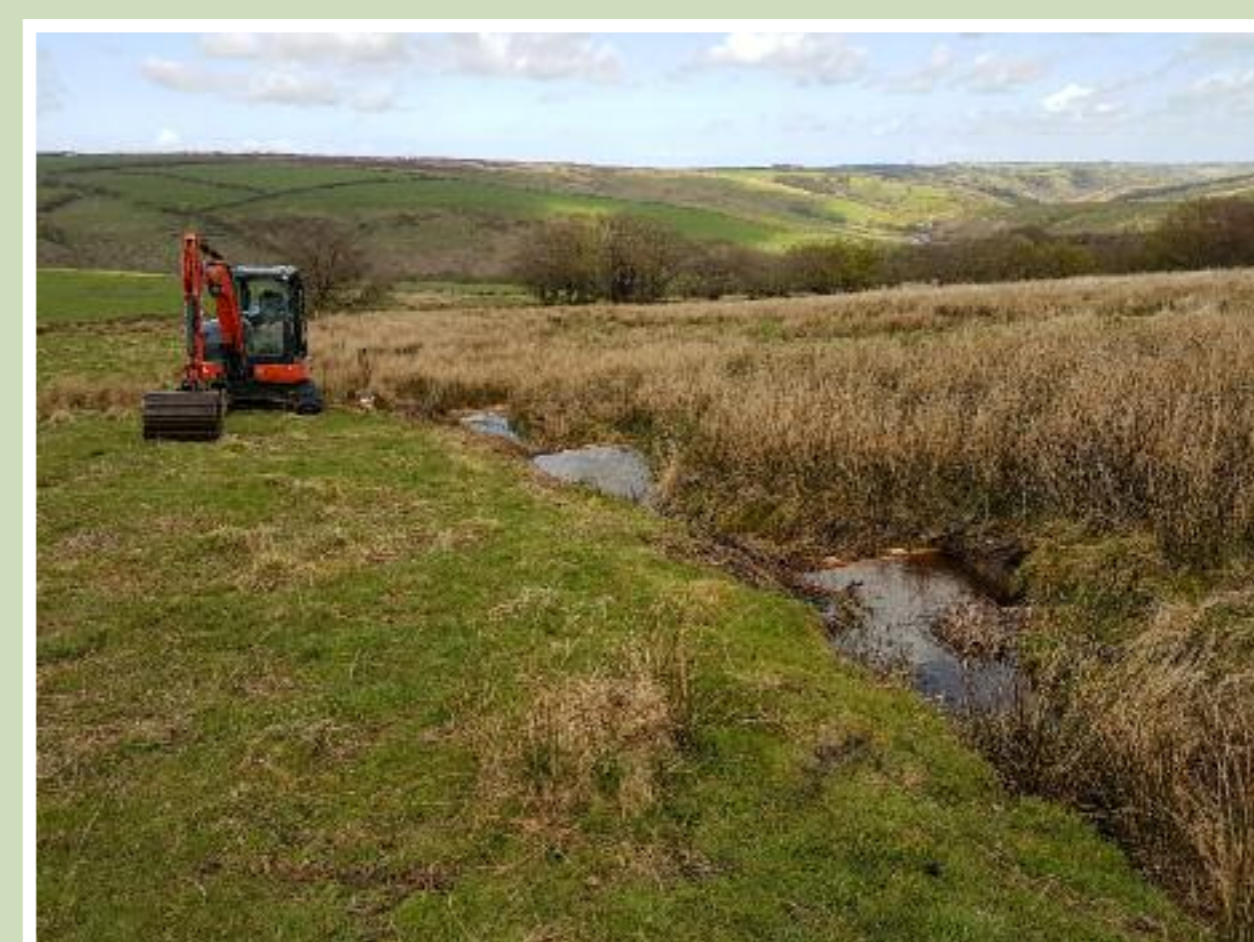
At the interface of the valley mire and grassland low wooden blocks were constructed. Slowing the flow of water along the ditch, improving the water table in the adjacent peatland area, whilst not impacting on the grassland area or the farmers main access route.

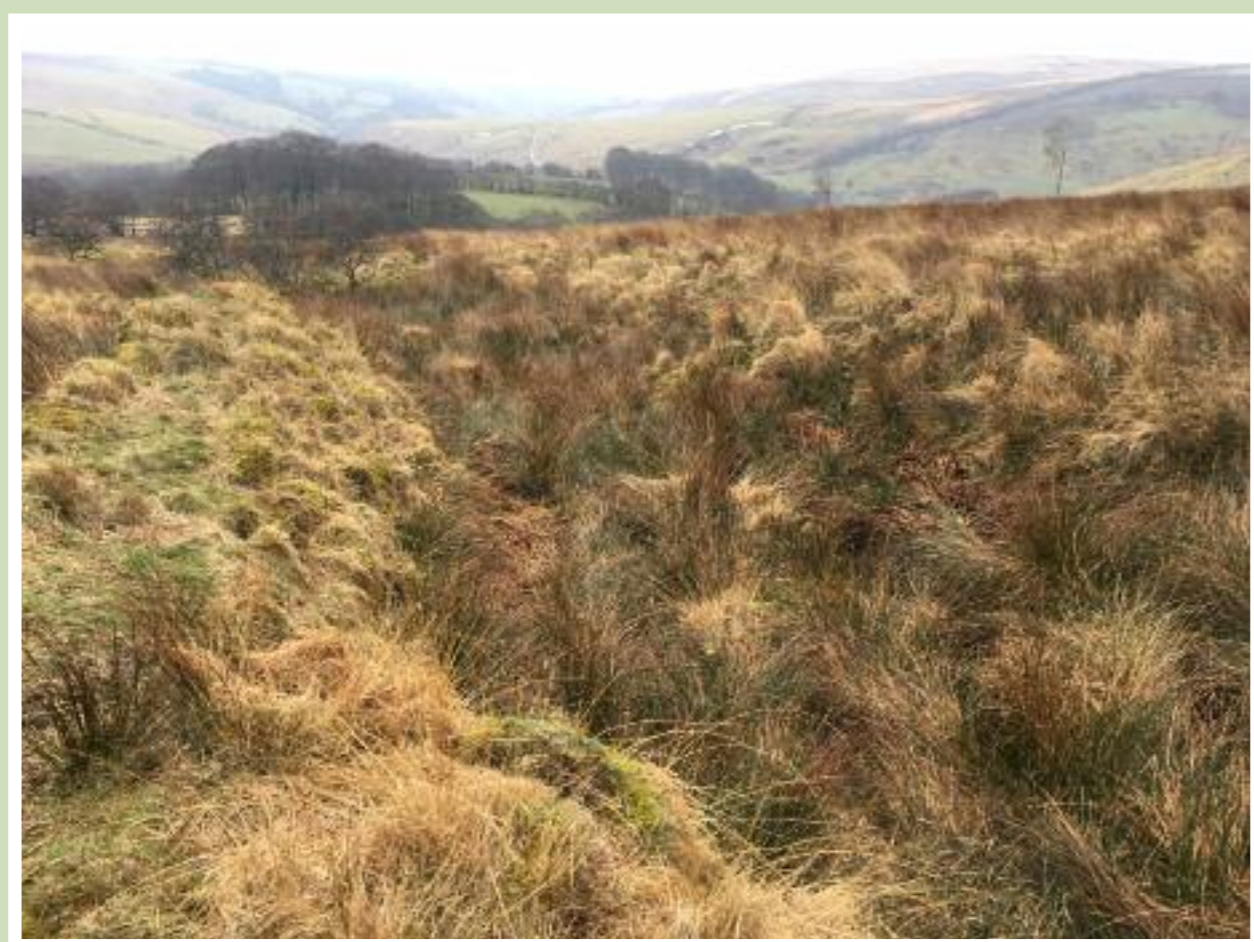
Left: Gully prior to work: Photo credit Environment Agency

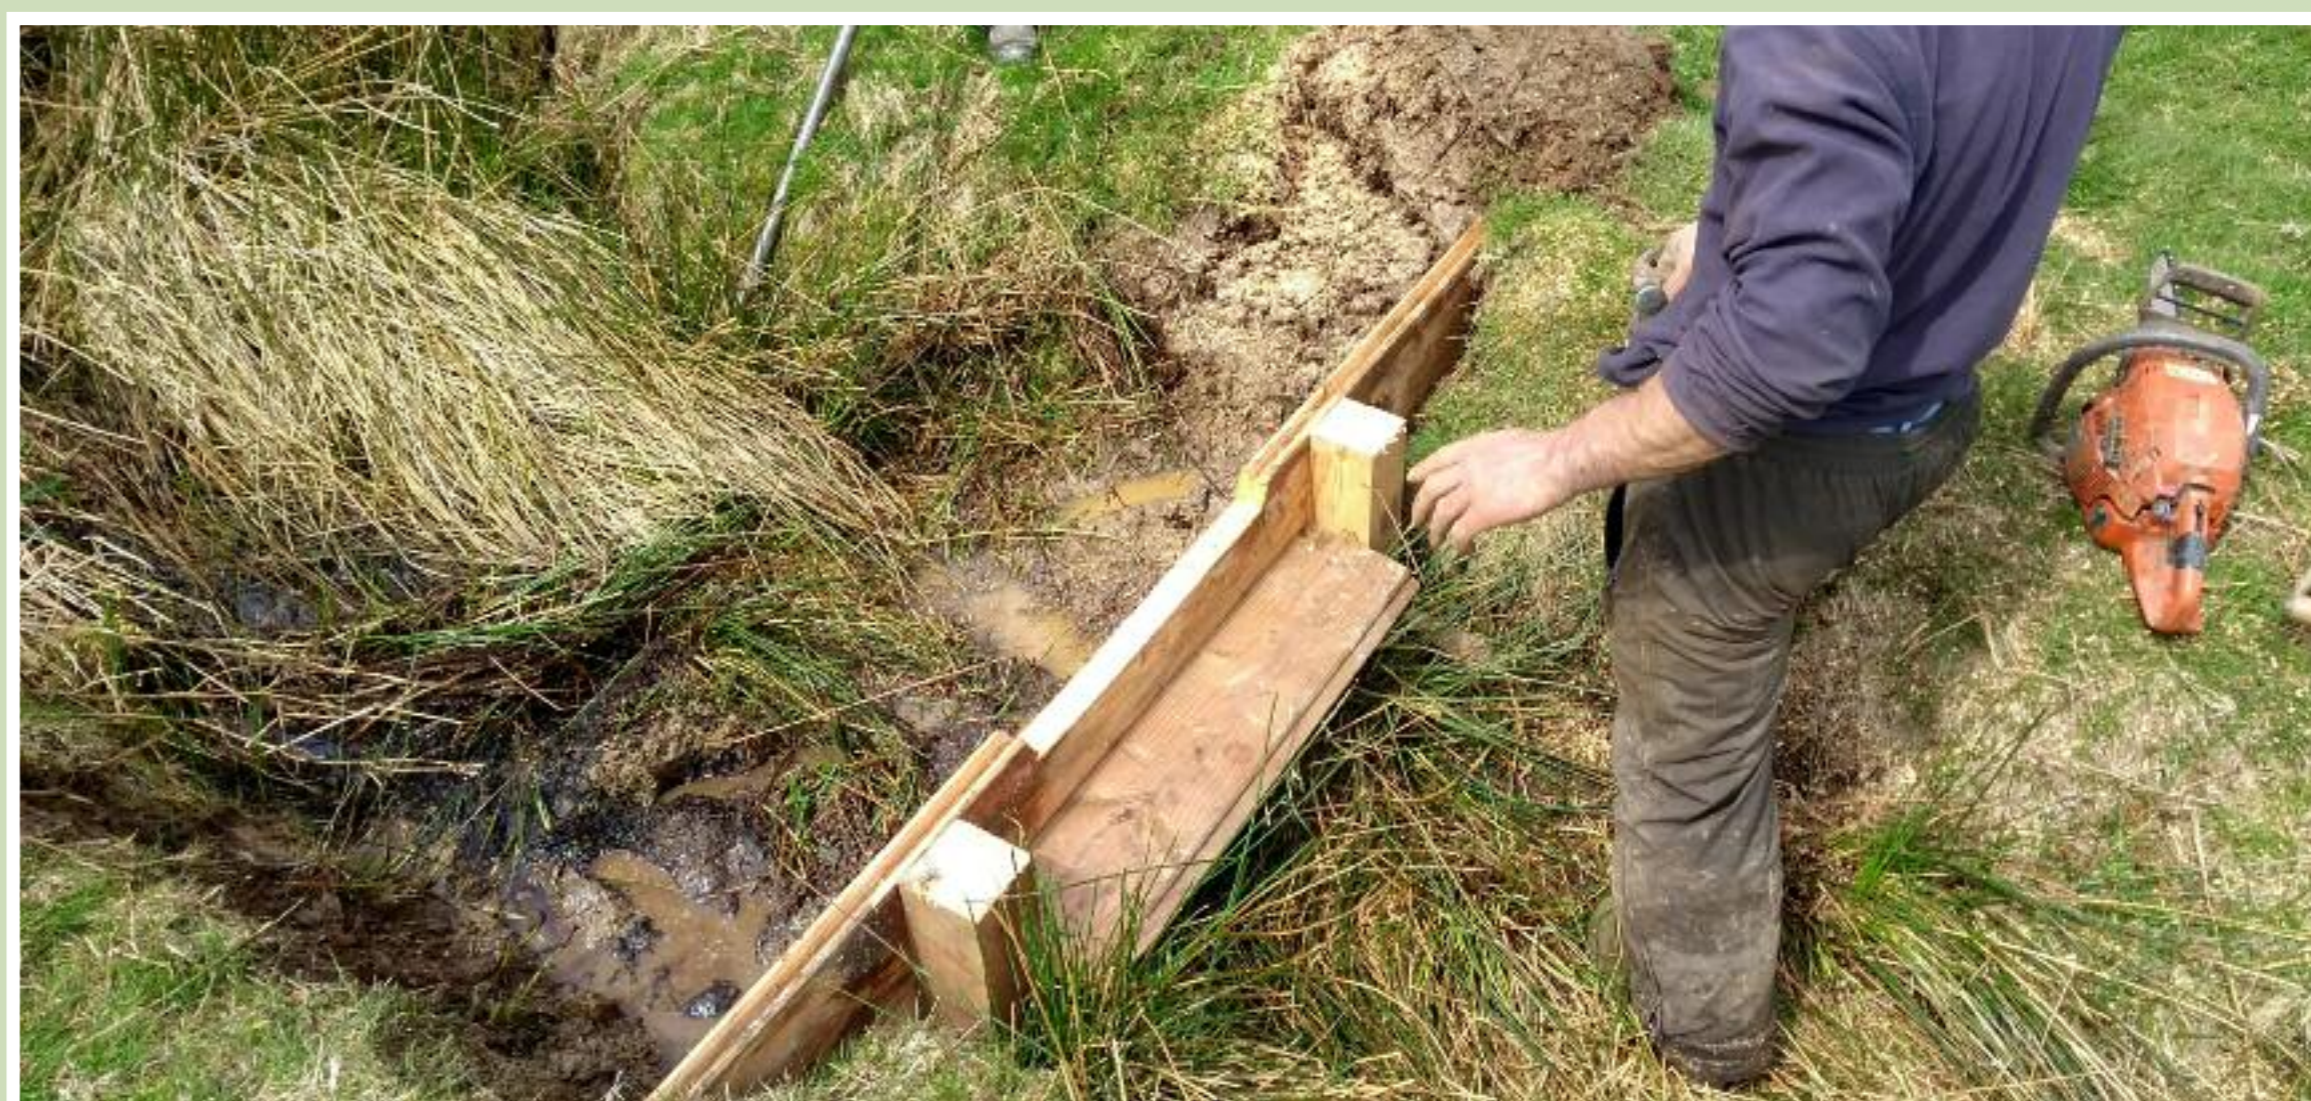
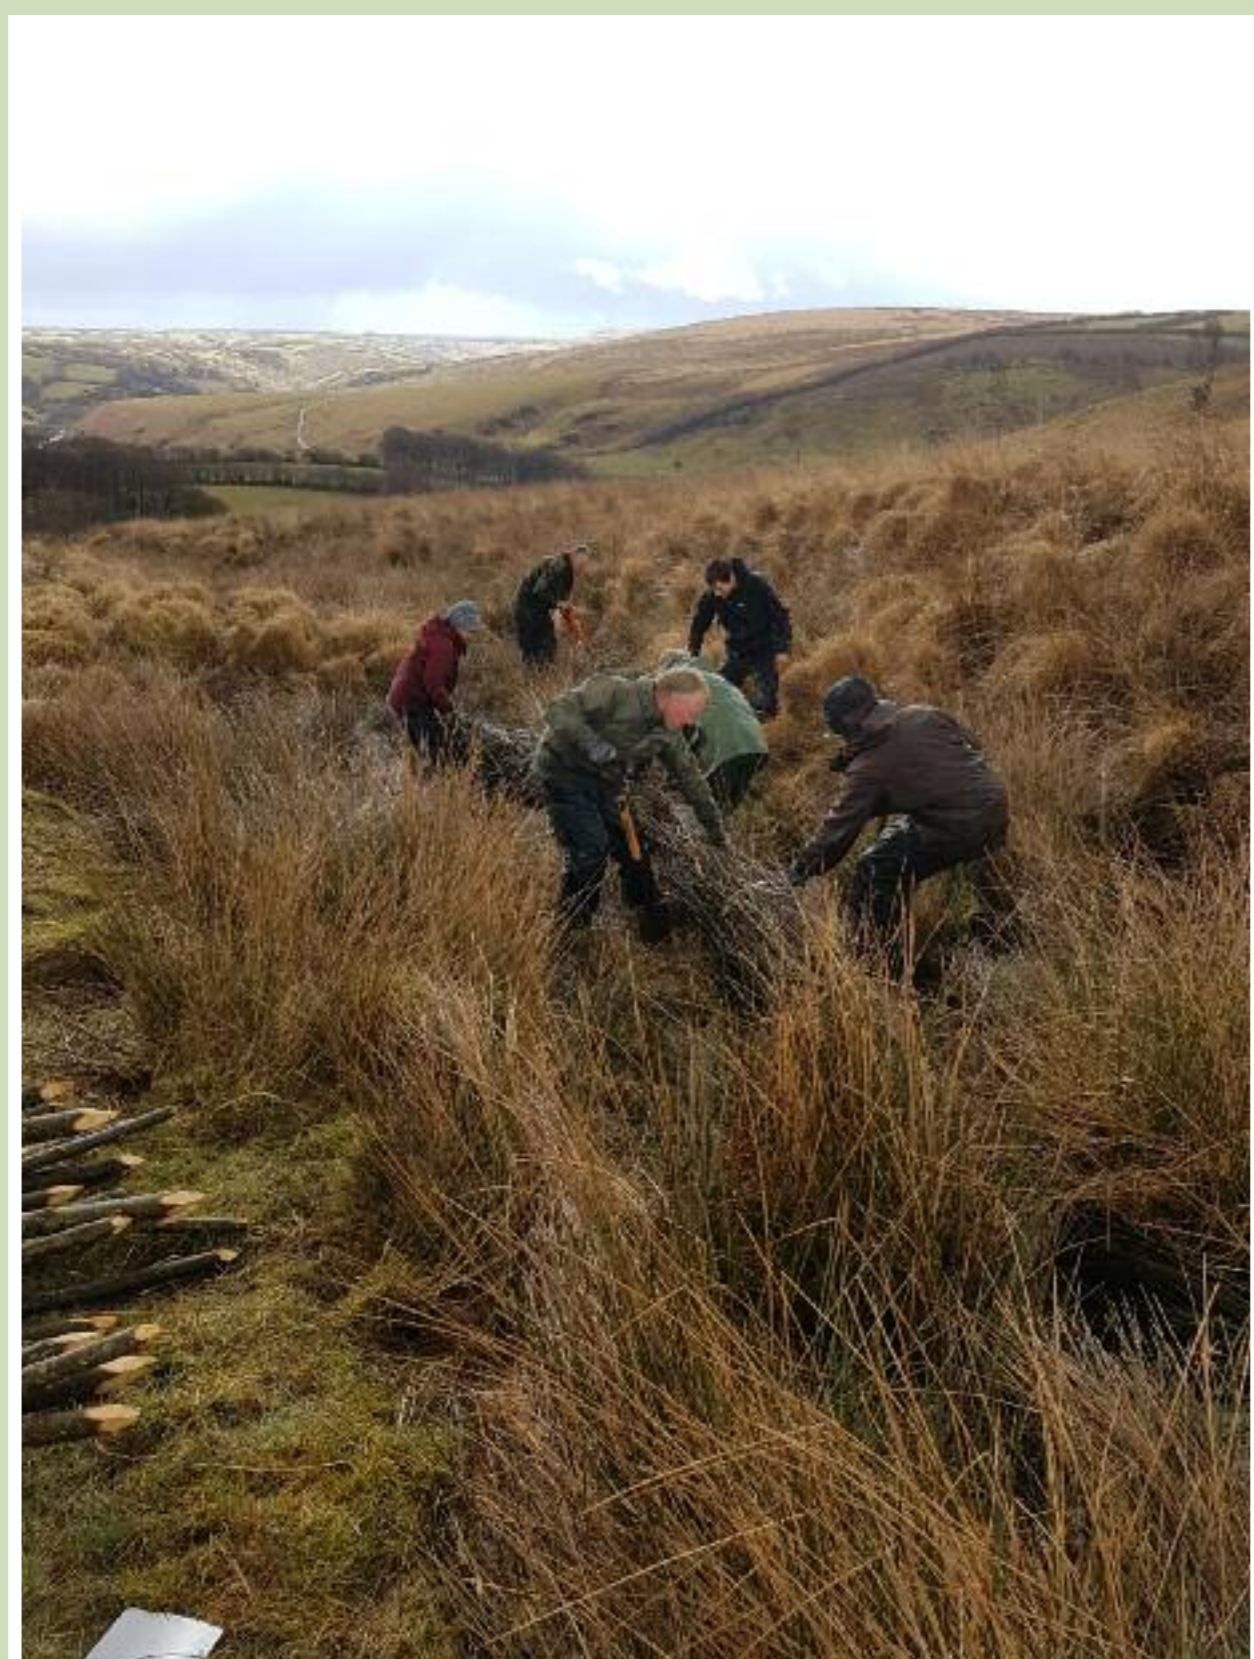
Below: Willow fascines installed in the gully.

As the grey willow fascines grow and root into the gully this 'Natural Flood Management technique' will begin the process of alleviating peat and sediment loss going downstream and create a small corridor of wet willow woodland.

The willow fascines were installed by the fantastic EMP volunteers and staff!

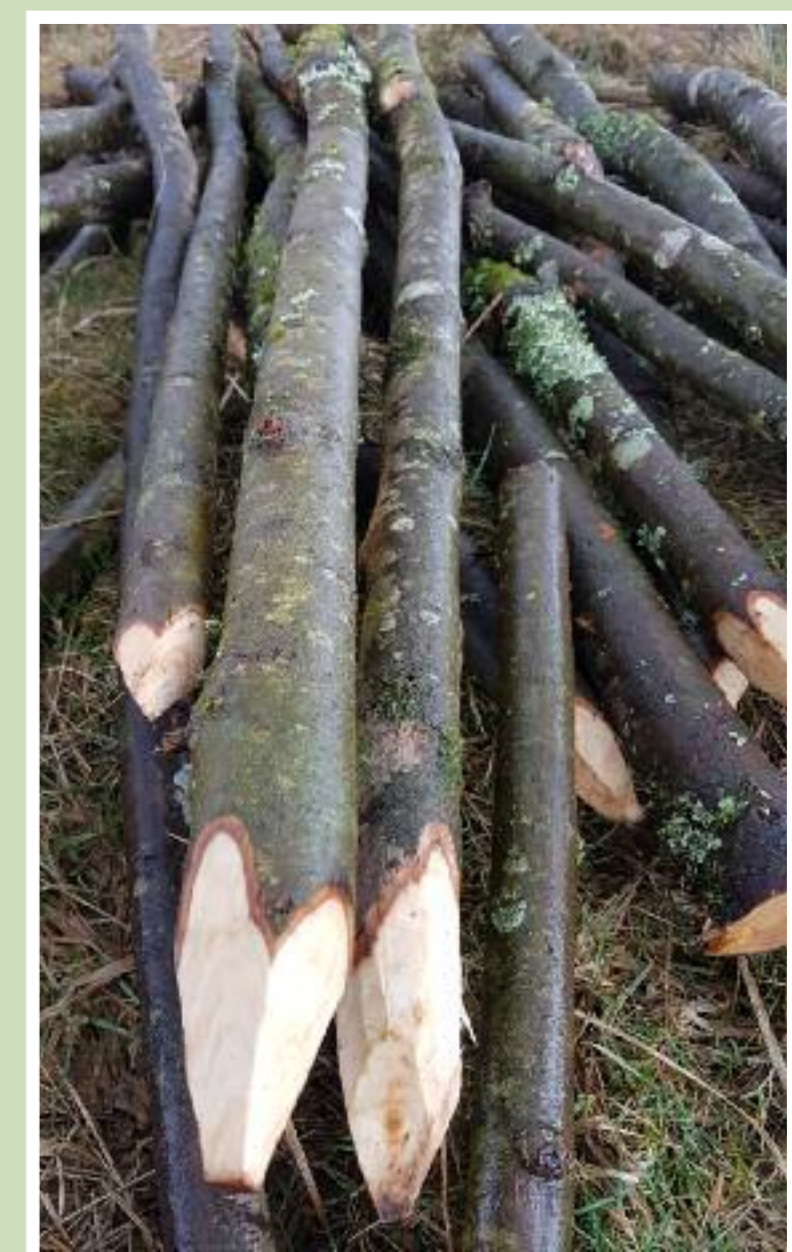
Right: Locally sourced grey willow was used. Cut and constructed by Heart Wealden Enterprise Ltd. Dimensions of the fascines 2500mm x 400mm., and stakes 1500mm.
