Yorkshire Peat Partnership

WORKS MONITORING REPORT

May 2017

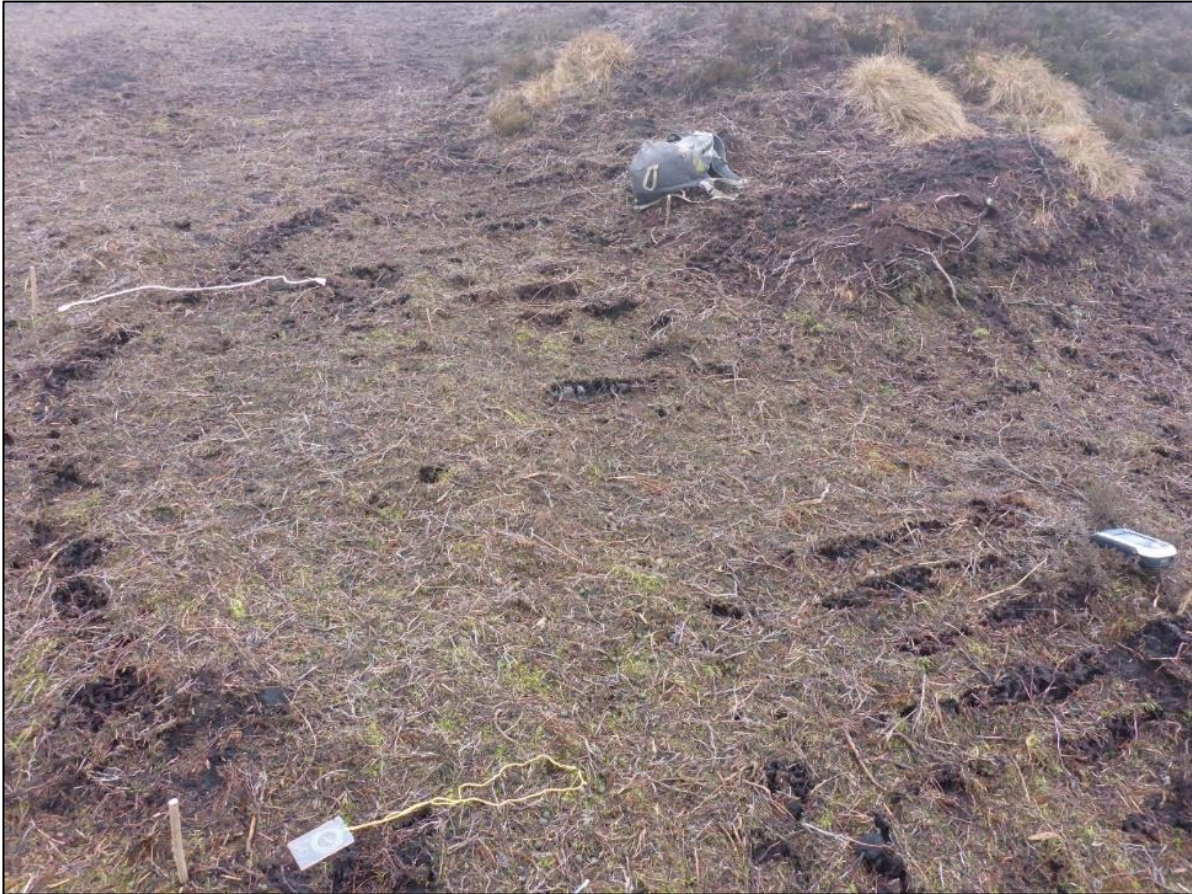
Figure 1: A 2 x 2 metre quadrat for assessing revegetation cover and species on bare peat, Ramsgill 2017

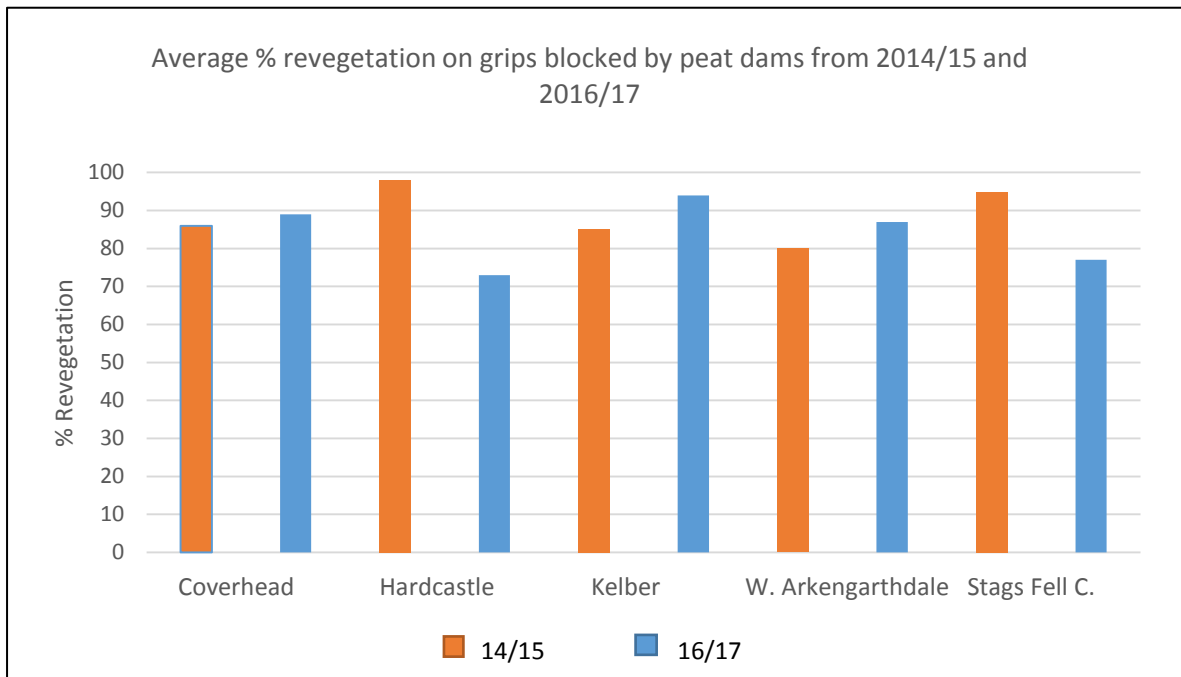
Figure 7: Data comparing vegetation cover from sites monitored in 2014/15 and 2016/17.

Out of the five sites average vegetation cover has gone up on three (Coverhead, Kelber and West Arkengarthdale) but down on Hardcastle and Stags Fell Central (Figure 7). Part of the decline on Hardcastle could have been due to recent burning over the features being monitored. Also, the data from 2014/15 for Stags Fell had been gathered after heavy snow, so may have been less accurate.

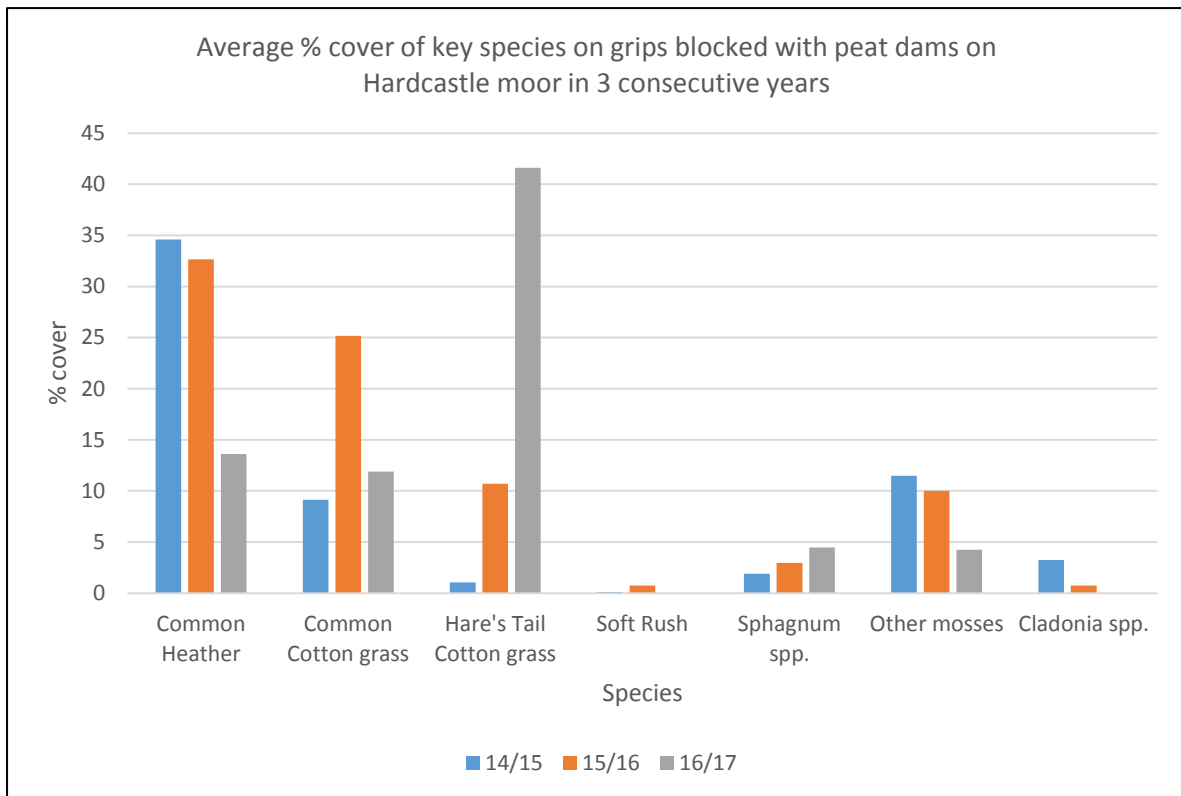
Figure 8: Data comparing percentage of species cover on Hardcastle moor monitored in 2014/15, 2015/16 and 2016/17.

Hardcastle (Figure 8) has particularly interesting changes with no records of Soft Rush *Juncus effusus*; a decline in grasses, mosses, *Cladonia*, *Sphagnum palustre* and *S. fallax*. This all points to a reduction in water flow and an increase in acidity. To substantiate this trend, these species are being replaced by new blanket bog species including cranberry *Vaccinium oxycoccos*, and several sphagnum species including *S. subnitens* and *S. magellanicum*. All of this is showing a very positive shift to blanket bog communities.

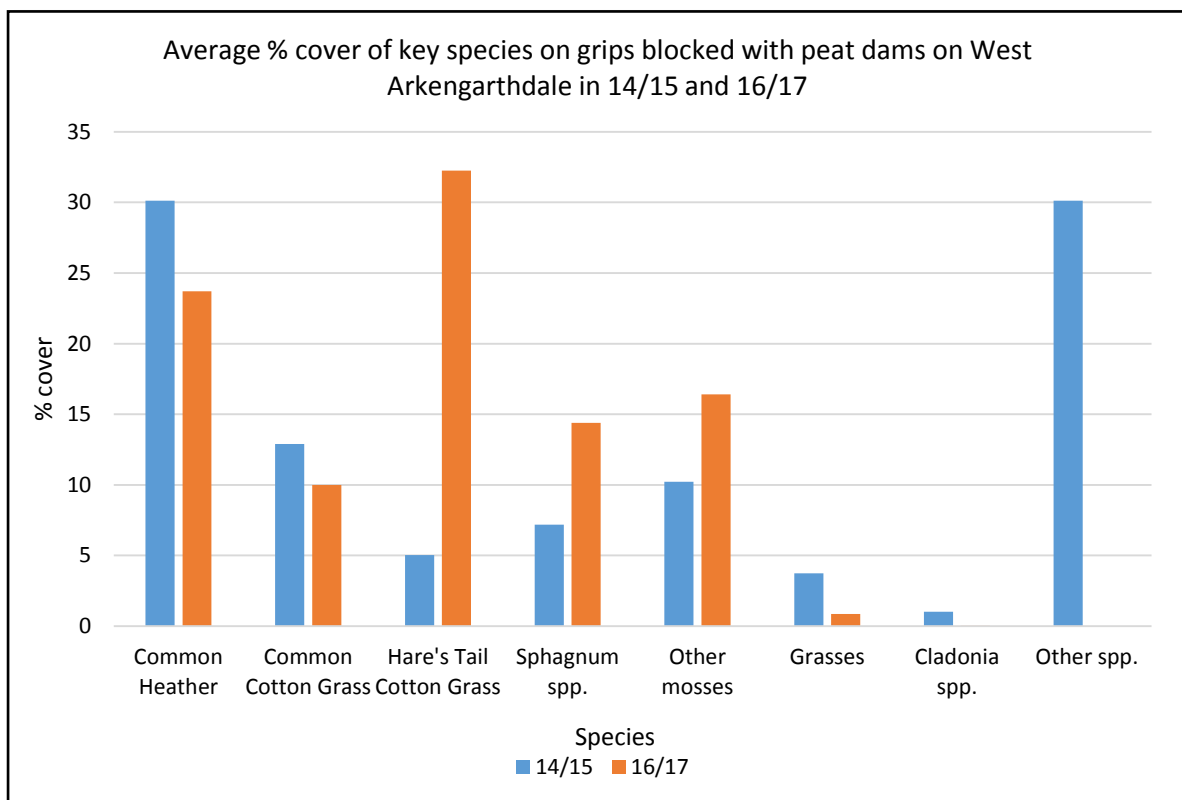
Figure 9: Data comparing percentage of species cover on West Arkengarthdale monitored in 2014/15 and 2016/17.

There was no data for species on Stags Fell Central due to the snow cover at the time of monitoring in 2015, but on the other 4 sites percentage cover of Common Heather *Calluna vulgaris* has decreased; Hare’s Tail Cotton-grass *Eriophorum vaginatum* has increased substantially and sphagnum species have also shown a steady rise.

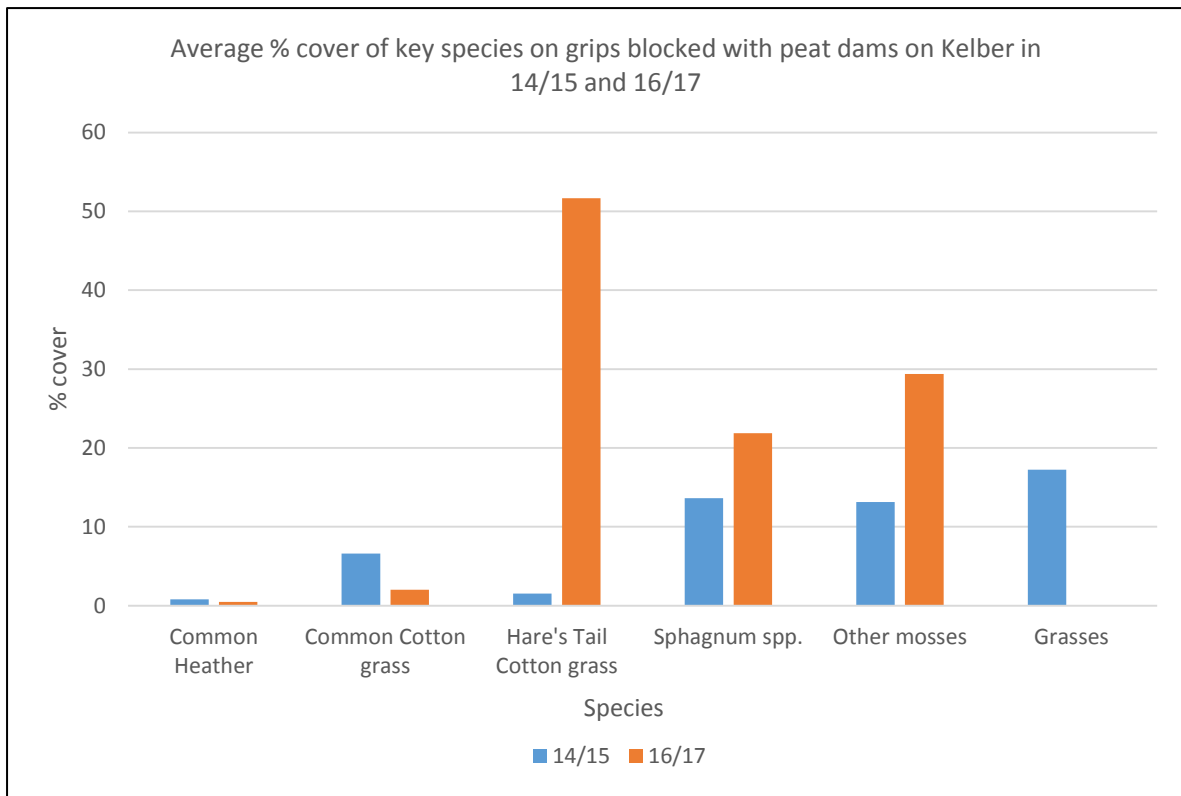
Figure 10: Data comparing percentage of species cover on Kelber moor monitored in 2014/15 and 2016/17.

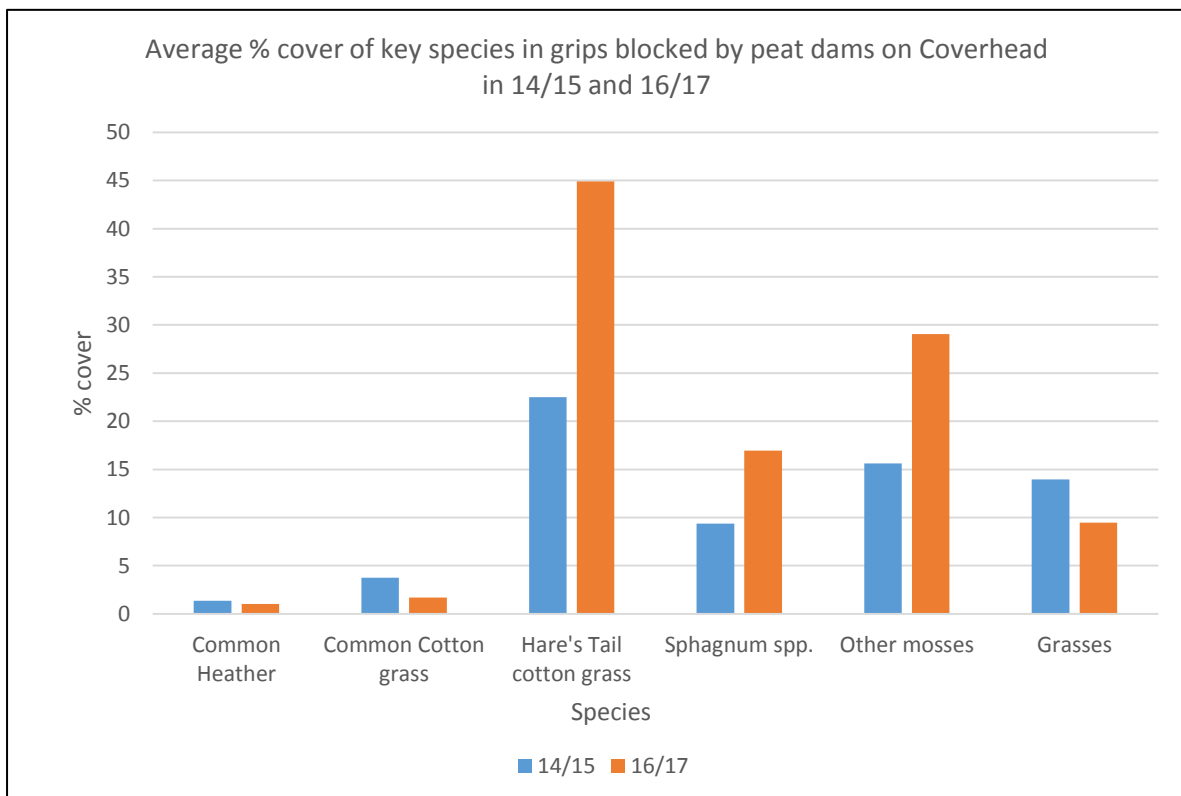
Figure 11: Data comparing percentage of species cover on Coverhead monitored in 2014/15 and 2016/17.
