1. Introduction

As part of the Sustainable Catchment Area Management Programme (SCAMP NI), NI Water worked in partnership with the Royal Society for the Protection of Birds and Northern Ireland Environment Agency to conserve and enhance this site. This involved restoring the quality and function of the bog by blocking drainage channels and working with local graziers to reduce grazing pressure.

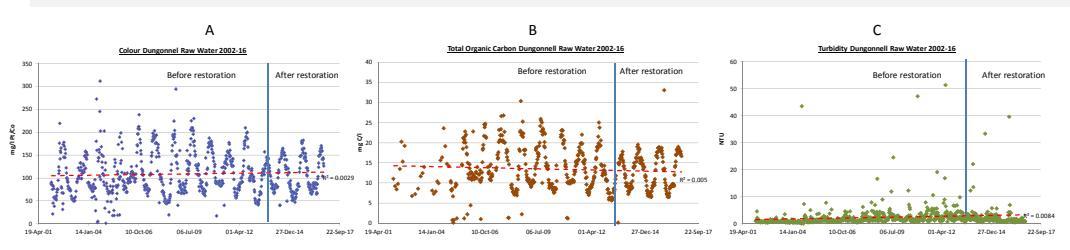
Figure 7: Raw water quality data parameters at Dungonnell Reservoir for (A) colour, (B) Total Organic Carbon and (C) Turbidity

- Condition assessments by Northern Ireland Environment Agency will highlight any improvements in the condition of the bog.
- · Raw water quality from the catchment is continuously monitored at the reservoir.
- Since drain blocking work was completed, Colour (Fig. 7(A)) and TOC (Fig. 7(B)) data indicates that spikes are less pronounced and fewer
 outliers occur. The quality of the raw water has stabilised and this may be attributed to restoration work at the catchment.
- The data for turbidity (Fig. 7(C)) is less conclusive.
- Further long term benefits in the quality of raw water provided by the catchment will become apparent over time as reduced grazing pressure and drain blocking leads to improvements in the bog condition and restoration of bog hydrology.
