Restoration of a raised bog at Portmoak Moss Woodland Trust Scotland

Feb 2011

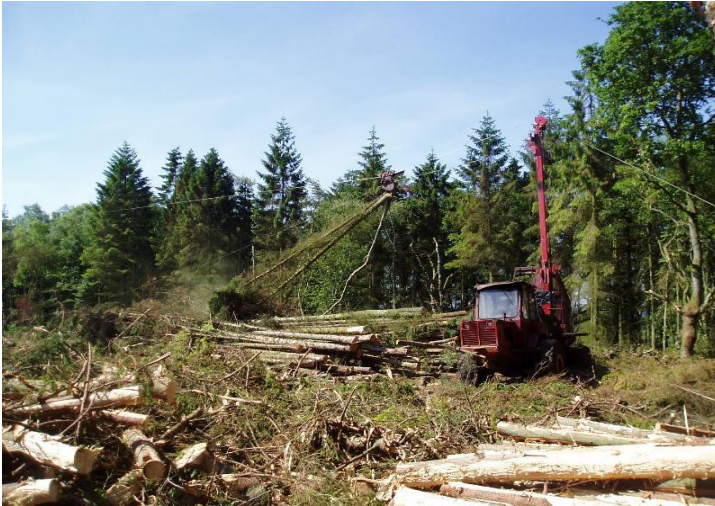
Sensitive extraction of felled material using a 'Skyline' to prevent compaction of restoration area.

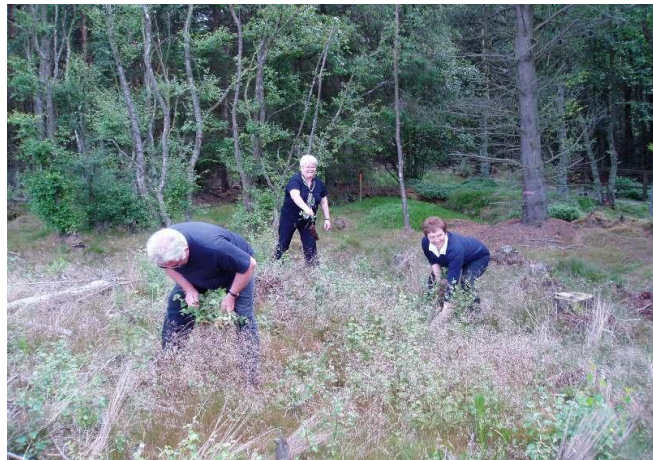
Volunteers hand pulling birch regeneration

The amount of birch regeneration on the felled area is greater than anticipated. A range of techniques have been tried and we are currently working in partnership with the Scottish Wildlife Trust on a three year project to control the regeneration. We hope maintained higher water levels will act as a natural control. The wood is managed in partnership with the Portmoak Community Woodland Group who also undertake birch-pulling workdays to supplement the chemical control.
